**NI 43-101 TECHNICAL REPORT**

**ON THE  
LOS CHAPITOS PROPERTY,  
AREQUIPA PROVINCE, PERU**

**Camino Minerals Corporation**

**NI-43-101 & 43-101F1  
TECHNICAL REPORT No. 327**

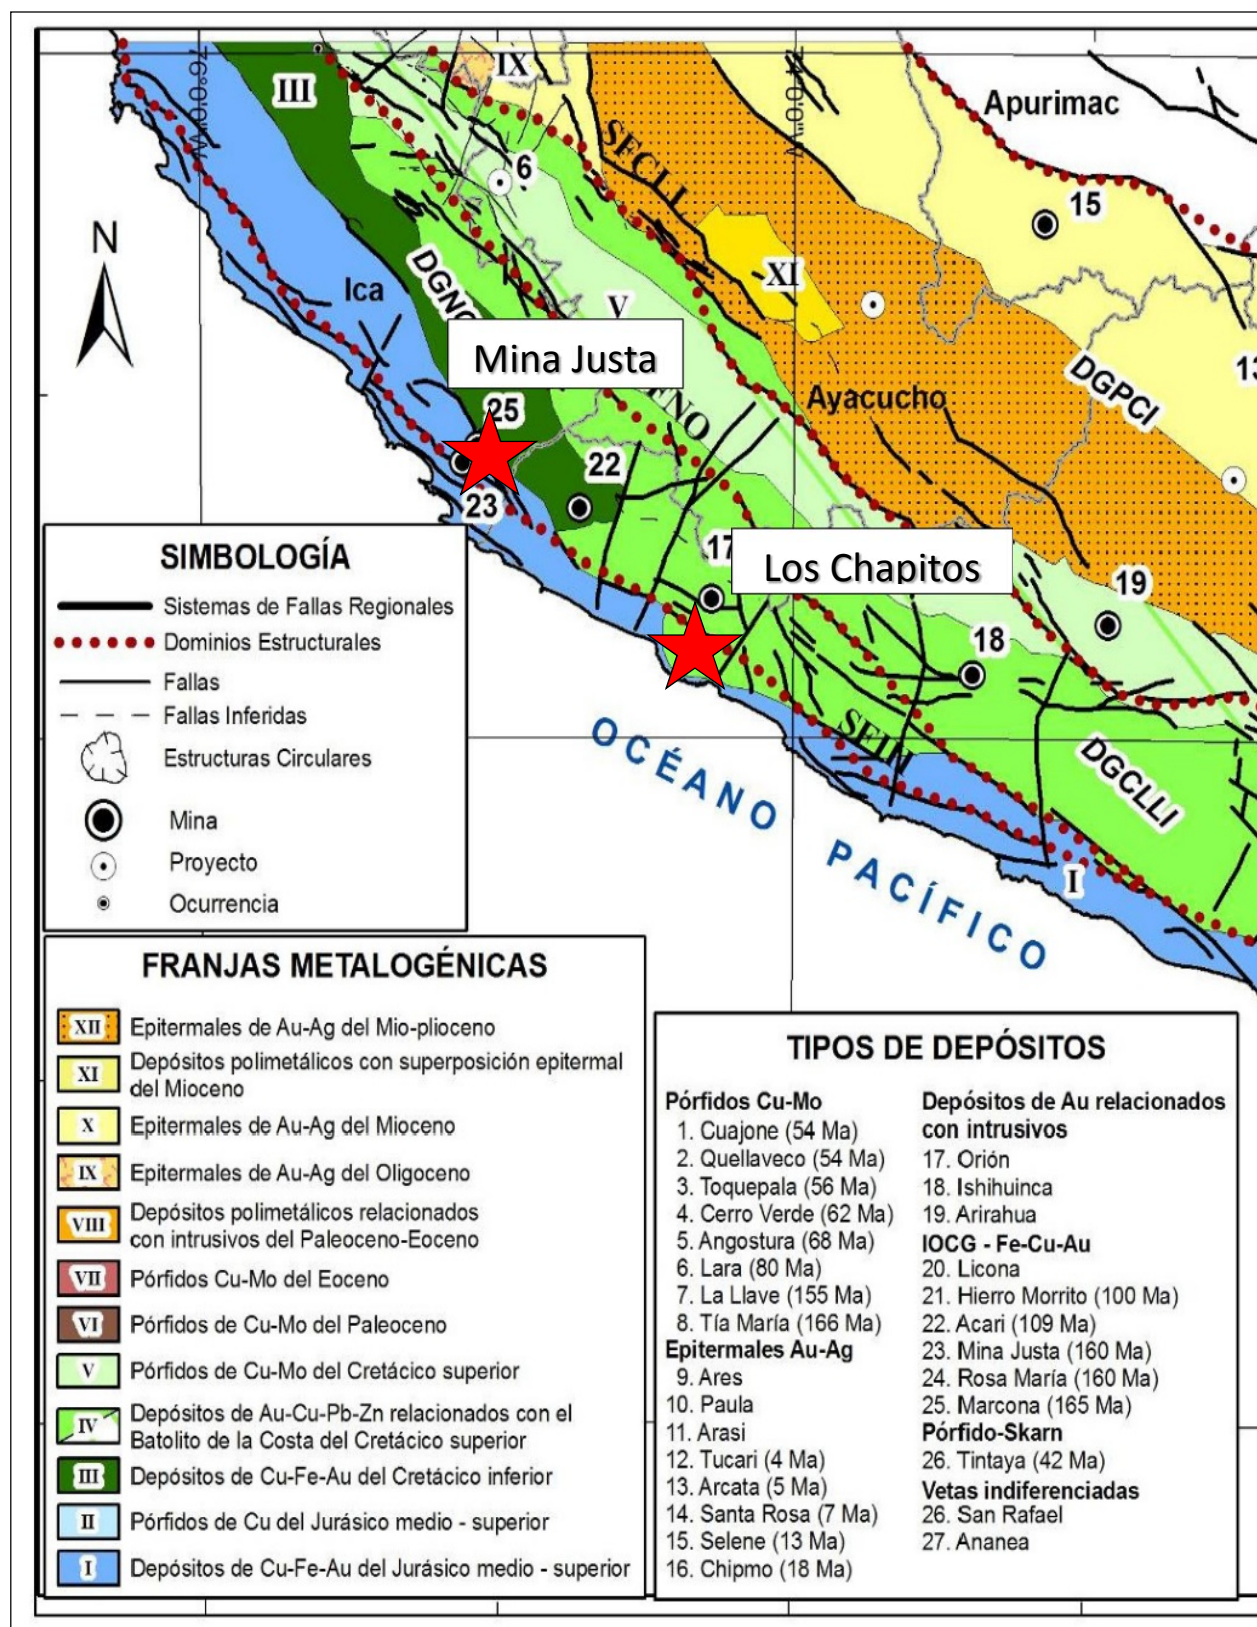
**Figure 7.1 INGEMET Map Showing Metallogenic Belts with Regional Geology and Major Structures**

The basement units of the stratigraphic section are comprised of Precambrian gneisses and schists. These are overlain by subordinate Paleozoic sediments and volcanics. In turn these Paleozoic units are unconformably overlain by predominately volcano-sedimentary rocks of Mesozoic age. These stratified units are then intruded by late Cretaceous igneous rocks that form batholiths, stocks, plugs, dykes and sills. Following this event are various dykes, sills and stocks ranging from felsic to mafic composition which intrude the entire sequence. These are late Cretaceous to Tertiary in age. Capping the sequence are Tertiary ignimbrites and Quaternary aeolian and colluvium deposits which cover a large part of the Coastal belt. The following regional geology-metallogenic-structural map shows Los Chapitos in relation to the nearest mines and mineral occurrences. (Figure 7.1)
