## **TECHNICAL REPORT FOR THE DOLORES PROPERTY, CHIHUAHUA, MEXICO**

In accordance with the requirements of National Instrument 43-101 “Standards of Disclosure for Mineral Projects” of the Canadian Securities Administrators

Effective date: June 30, 2022

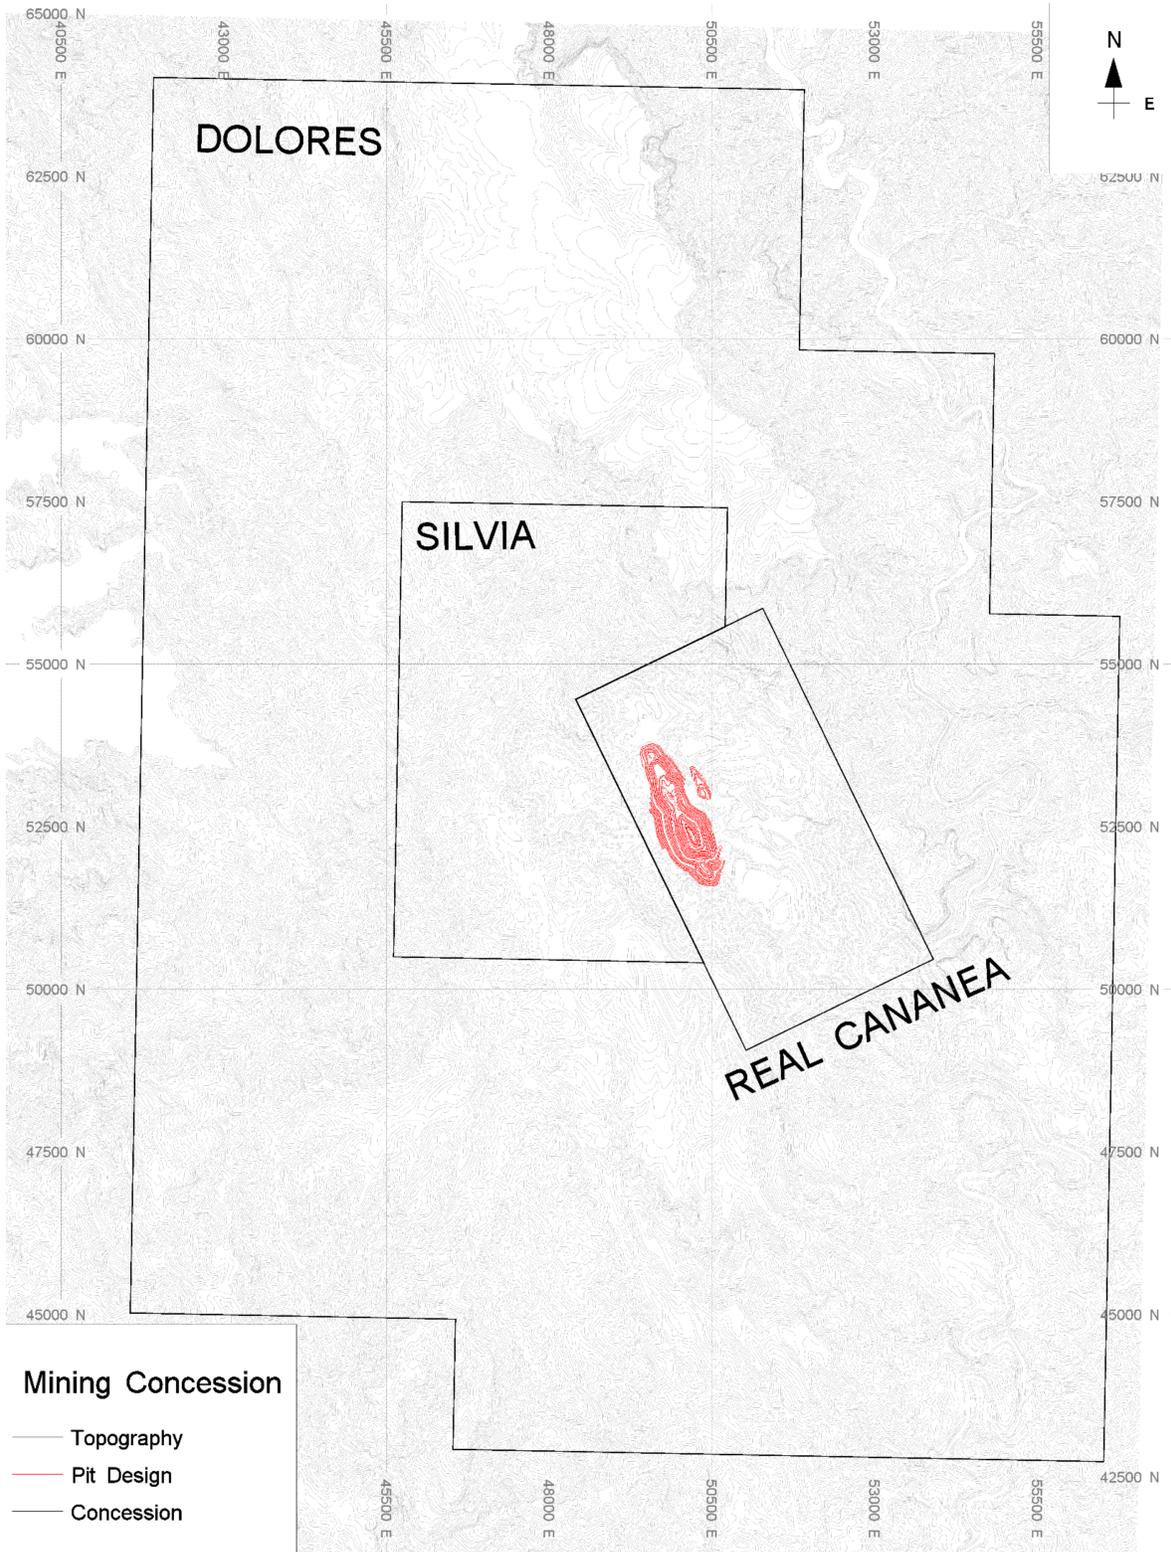
Figure 4.2 Mining concessions and surface rights

Details of the mining concessions are shown in Table 4.1. A plan of the mining concessions and surface rights relative to the pit outline at December 31, 2021 is shown in Figure 4.2.

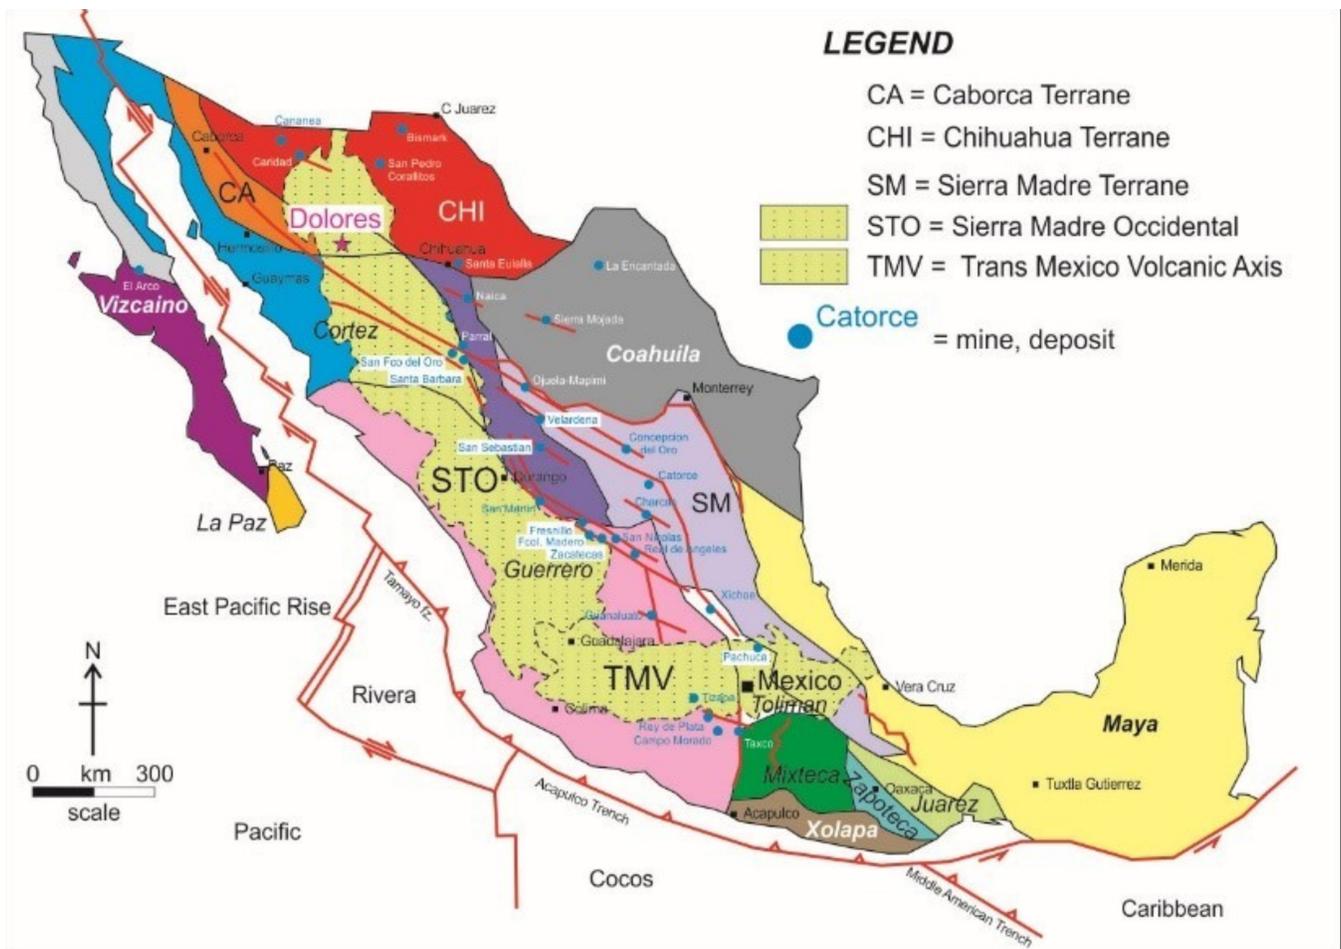
**Figure 7.1 Tectono-stratigraphic terranes of Mexico**

Pre-Tertiary rocks in northern and mid-Mexico comprise a jigsaw of oceanic and island arc terranes (Campa and Coney, 1983). Figure 7.1 shows a regional map of the northwest trending tectono-stratigraphic terranes of Mexico, as redrawn from Campa and Coney (1983). Strike-slip movement played an important role in assembling the terranes and continue to the present day.

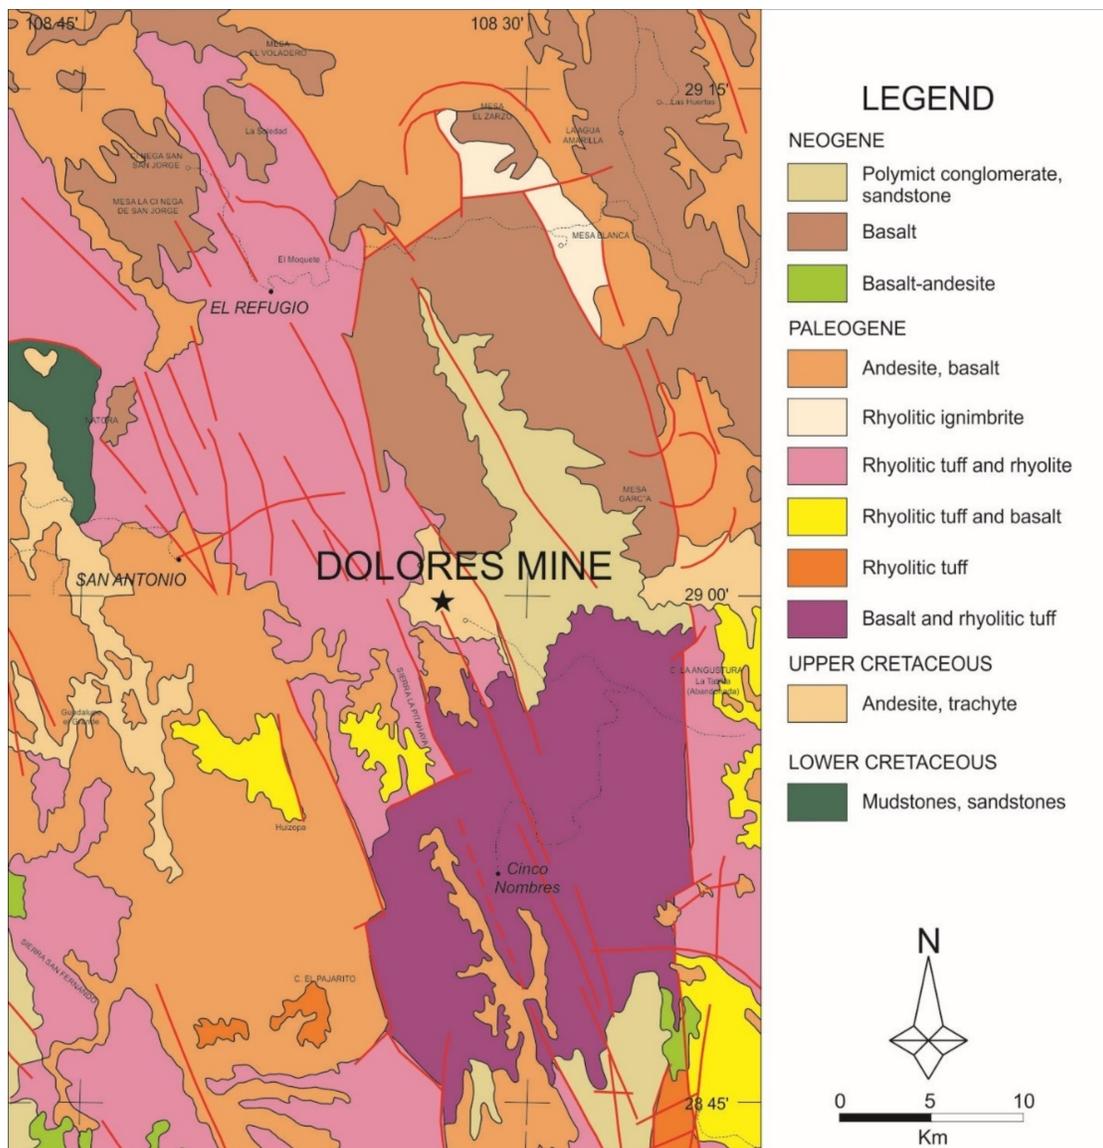
**Figure 7.2** Local geology map

The local geology shown in Figure 7.2 is based on the 1:250,000 Madera (H12-9) and Tecoripa (H12-12) sheets produced by the Servicio Geológico Mexicano.

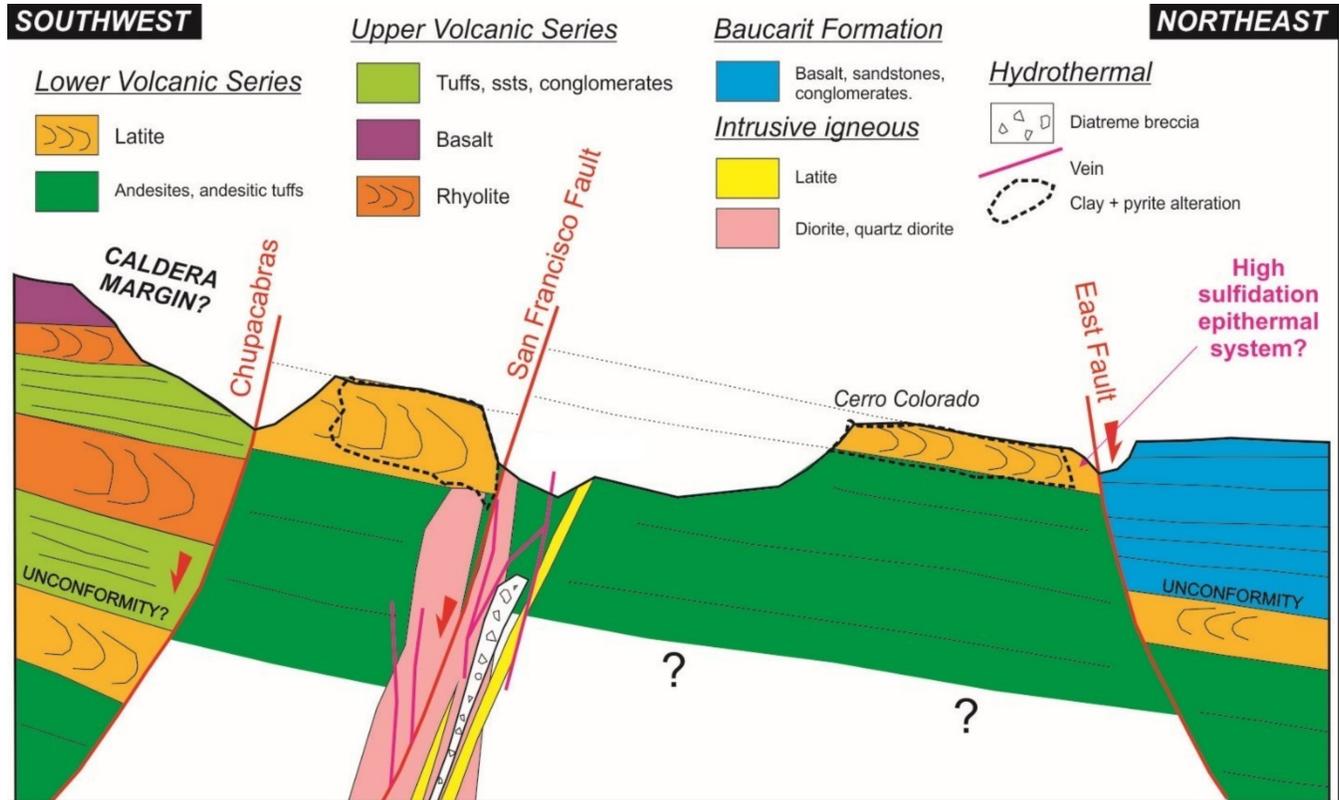
**Figure 7.3 Stratigraphic and structural relations cartoon**

Field observations indicate that the contacts between the Lower and Upper Volcanic Series comprise mostly faults, as shown in Figure 7.3 (not to scale). The most important faults, from west to east, are the Chupacabras, San Francisco and East Faults. The San Francisco Fault and its footwall host most of the mineralization on the Property.

Colorado (shown in Figure 7.3). It also occurs widely on the west side of the San Francisco Fault, up to the Chupacabras Fault and forms most of the high west wall of the open pit.

The Chupacabras Fault throws down rocks to the west by about 200 m to 400 m while the East Fault drops the Baucarit Formation down to the east by about 350 m. The San Francisco Fault throws down latite lavas by about 300 m to 500 m to the west and is marked by a corridor of dikes and stocks. The overall geometry is therefore horst-like. The Upper Volcanic Series appears much thicker to the west of Chupacabras (Figure 7.3).

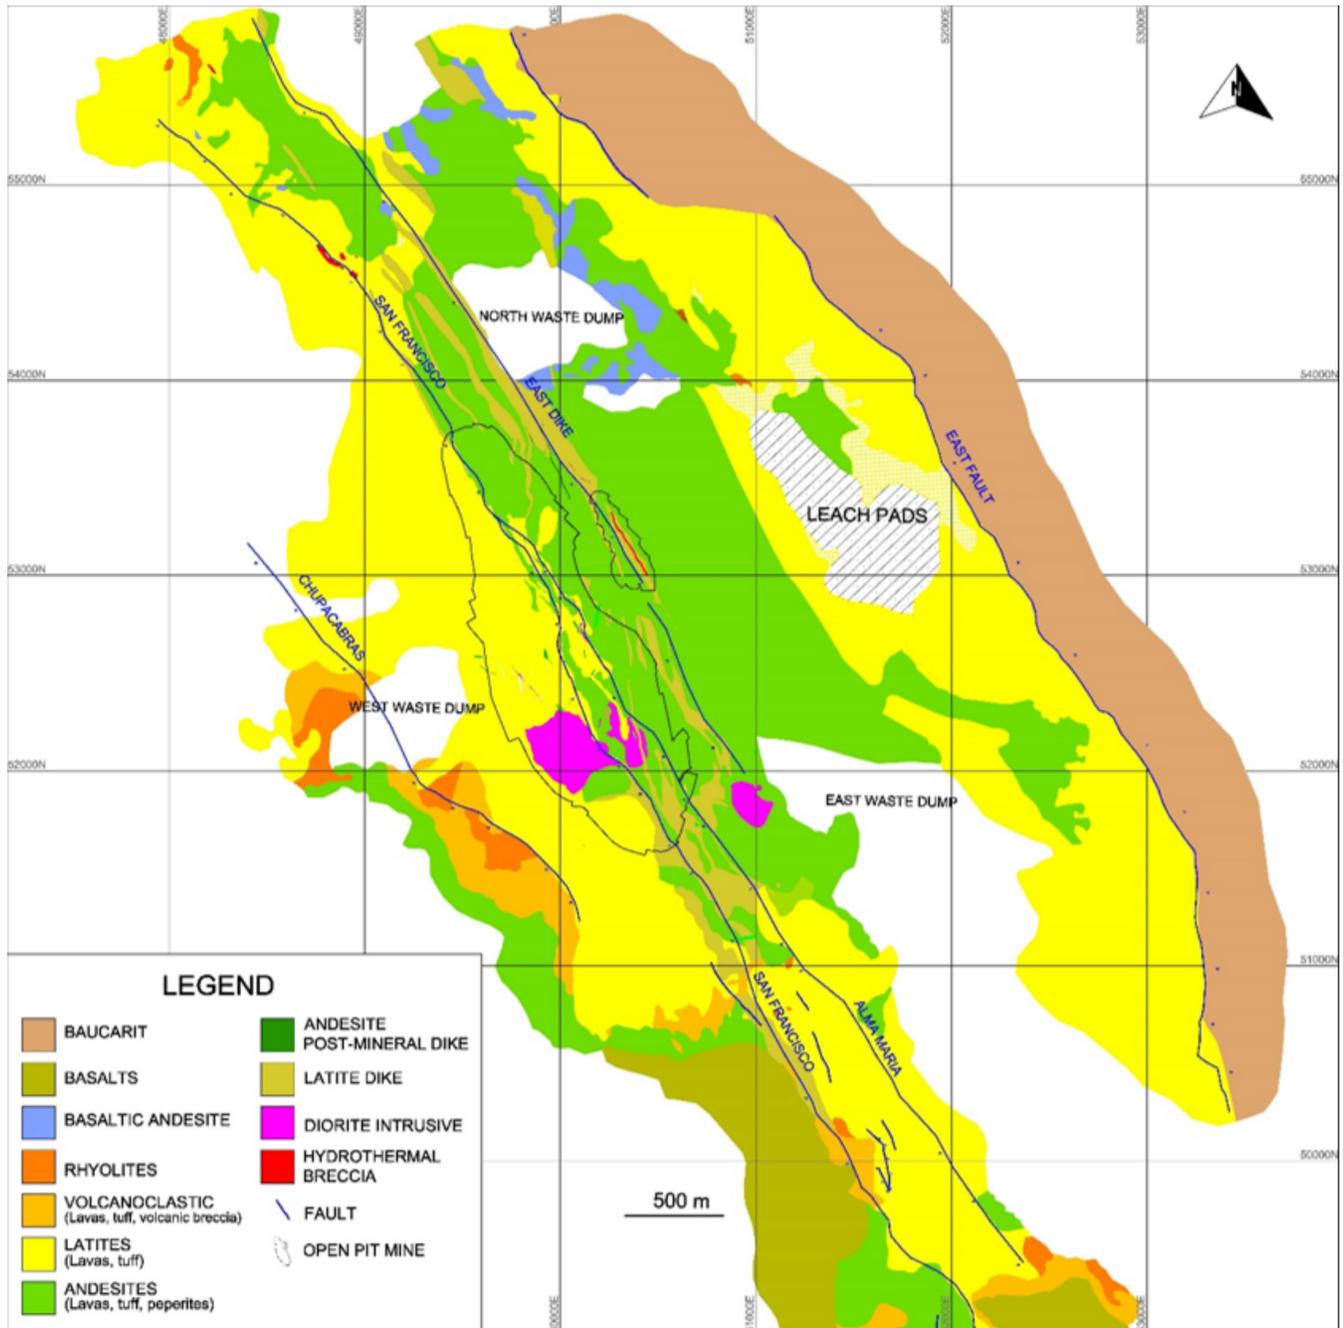
**Figure 7.4 Simplified Property geological map**

A simplified geological map of the Property is shown in Figure 7.4. The Lower Volcanic Series consists of a lower andesitic sequence overlain by latites. The main andesitic outcrop forms a wide strip of alternating dark and light green units between the San Francisco and East Faults. It is the main host for mineralization and is cut by a swarm of north-northwest striking dikes. Dark green units comprise massive, porphyritic andesite and basaltic andesite with feldspar and clinopyroxene phenocrysts. The light units are either strongly amygdaloidal andesite or monomict andesitic breccias (autobreccias and transported volcanic breccias). Peperite forms at the bases of some andesite by the interaction of igneous rock and wet sediments. Other rock types in the Lower Volcanic Series include thin acid welded and crystal-rich tuffs, as well as bedded sandstones between andesite lava flows.

The amygdaloidal and oxidized basalts are probably thin lava flows, and have peperitic bases. The geological map shown in Figure 7.4 shows all other lithologies as volcanoclastics (labelled "Volc"). These comprise crystal tuffs, green non-welded pumice-rich lapilli tuffs, crystal-rich sandstones, and conglomerates with a mostly sub horizontal orientation.

The topographically, and stratigraphically, highest rocks comprise a thick porphyritic andesite flow (labelled "UAnd" in Figure 7.4), which is overlain by a basalt underlying the Dolores airstrip.

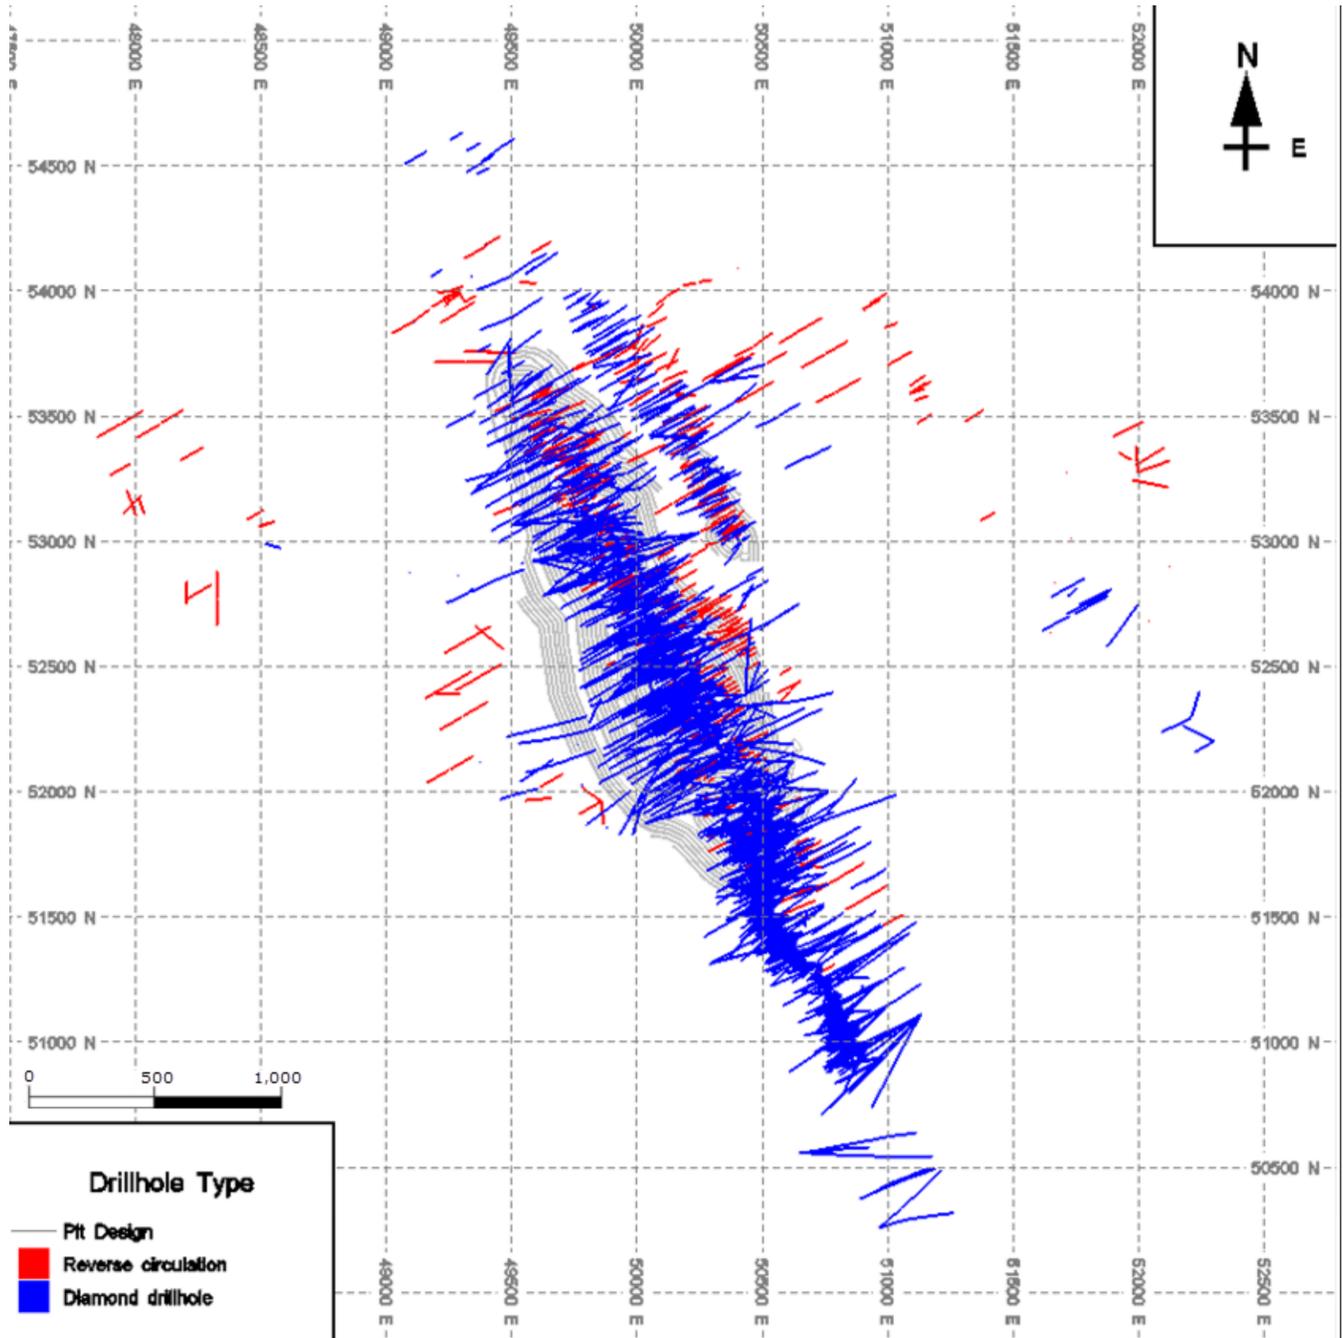
**Figure 10.1 Drillhole location map**

A plan showing the location of the drillholes completed to June 30, 2022, is shown in Figure 10.1. Cross sections showing the relative orientation and spacing of drillholes on a typical section are shown in Figure 14.2 and Figure 14.3.

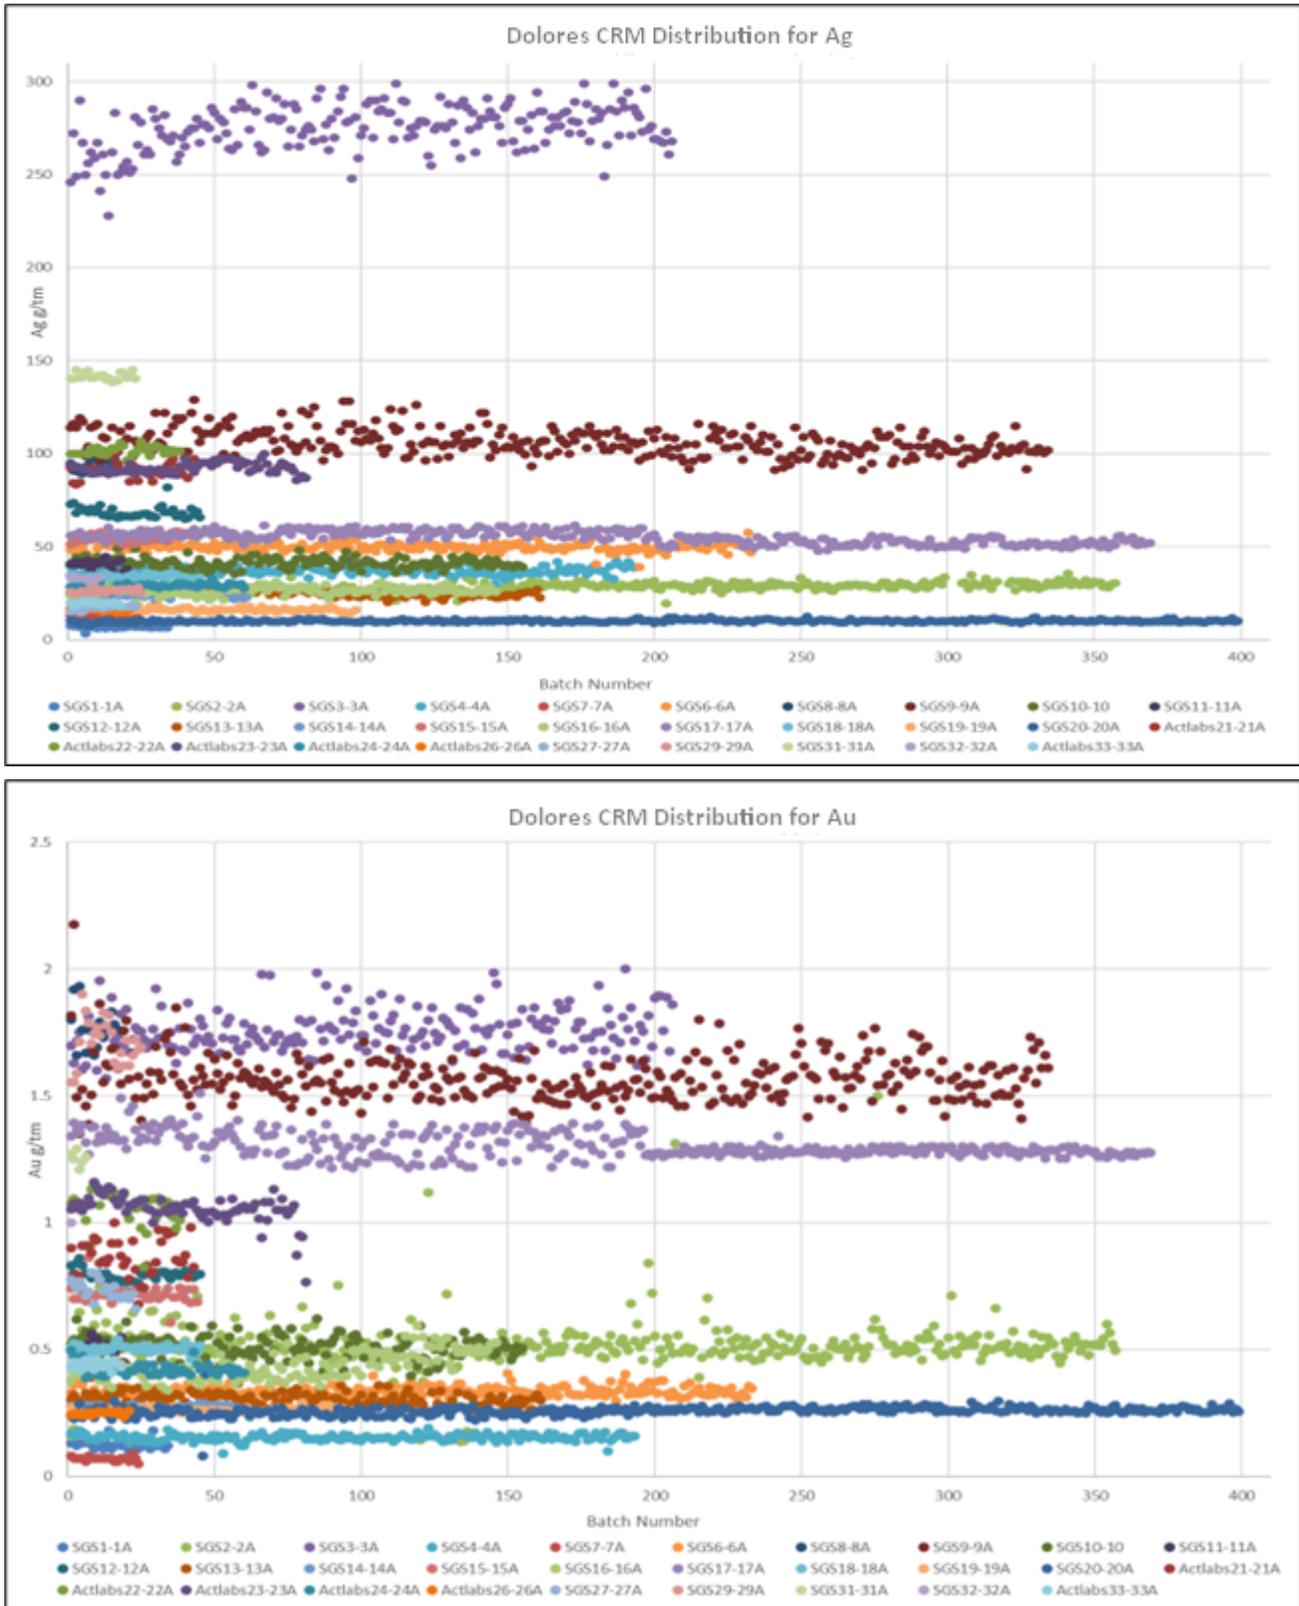
Figure 11.1 Performance for silver and gold CRMs from 2012 - 2022

Figure 11.1 shows the performance of all CRMs for both gold and silver. While most of them perform well, significant dispersion on CRMs SGS-3-3A and SGS-9-9A for silver and gold is evident in the plots. All samples associated with the failed standard were sent for re-analysis as part of the QA/QC protocol.

Table 11.6 shows a summary of the CRM performance over the 2012 to 2022 period where failures are determined as being  $\pm 3$  standard deviations from the expected value.

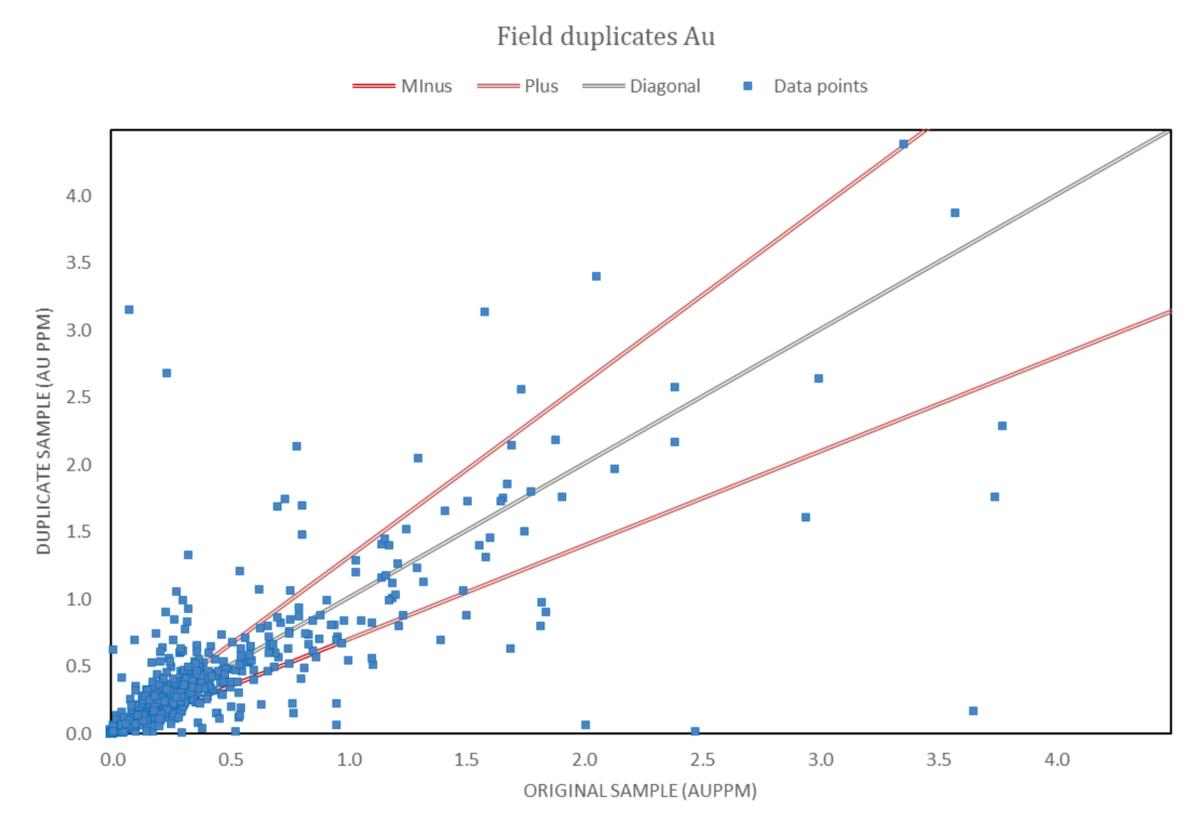
**Figure 11.2 RPD and scatter plot of field duplicates Au – 2014 - 2022**

Figure 11.2 shows the RPD and scatterplots of the field duplicates for Au from 2014 - 2022.

Note: Scatterplot is limited to 5 Au ppm.  
Source: PAS (2022).

The field duplicate performance is reasonable, although lower than the expected results, with Au and Ag performing similarly. The bias for the Ag and Au duplicates is skewed by one extremely high value pair submitted in 2022. The bias varies between favoring the original or the duplicate sample for both Au and Ag. Regardless, the bias is not a significant issue. In general, while laboratory issues may be a potential contributor to lower precision noted in the field duplicate data, the highly variable nature of mineralization is considered to be the main cause.

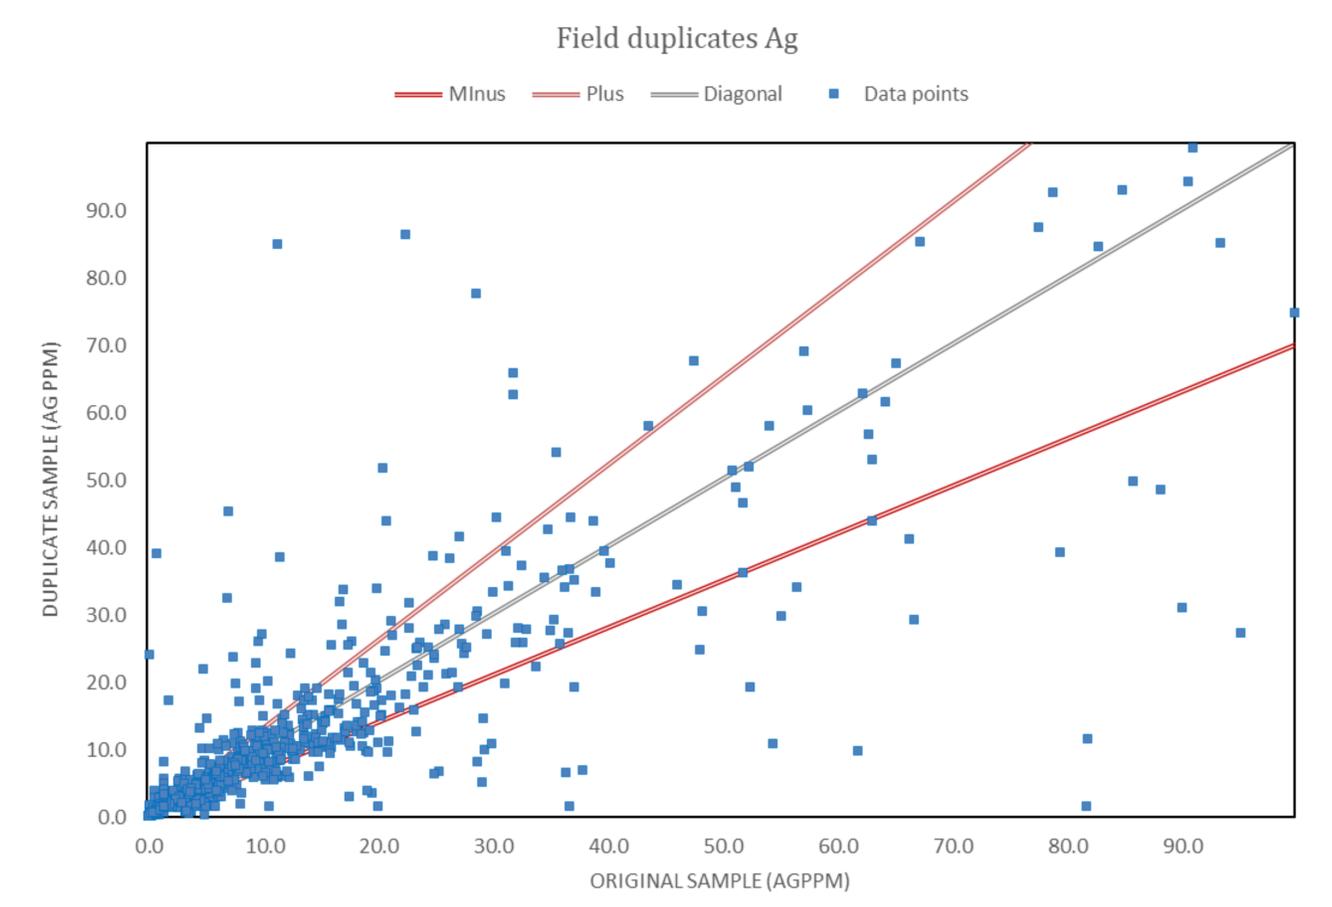
**Figure 11.3 RPD and scatter plot of field duplicates Ag – 2014 - 2022**

Figure 11.3 shows the RPD and scatterplots of the field duplicates for Ag from 2014 – 2022.

Note: Scatterplot is limited to 100 Ag ppm.  
Source: PAS (2022).

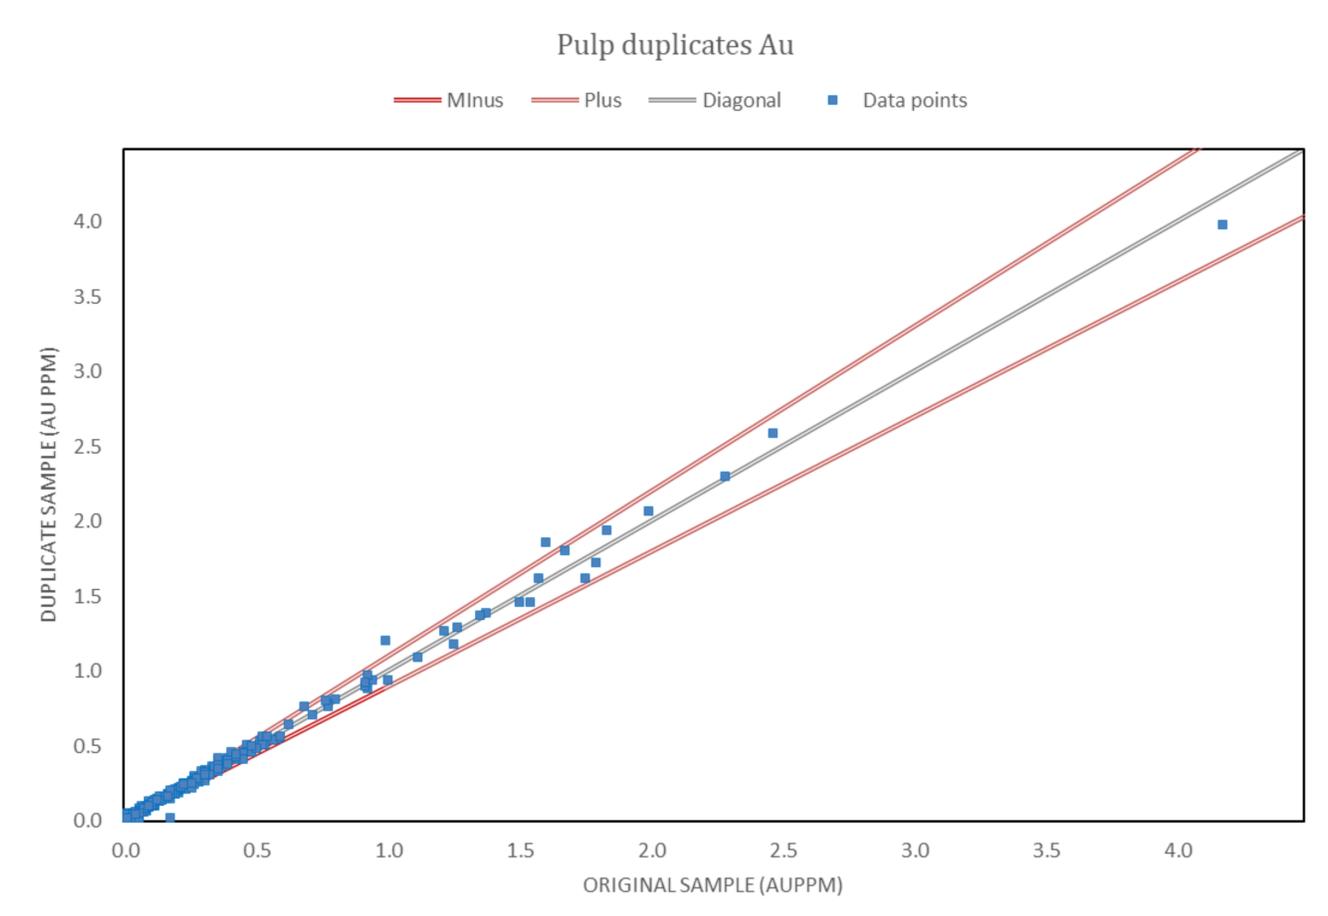
**Figure 11.4 RPD and scatter plot of pulp duplicates Au – 2014 - 2022**

Figure 11.4 and Figure 11.5 show the RPD and scatterplots of the pulp duplicates for Au and Ag, respectively, over the period from 2014 - 2022.

Note: Scatterplot is limited to 5 Au ppm.  
Source: PAS (2022).

The pulp duplicate performance is reasonable, with no appreciable bias observed. Pulp duplicates should be selected from material with higher grades, where possible. This will provide a larger database from which to further assess the duplicate performance.

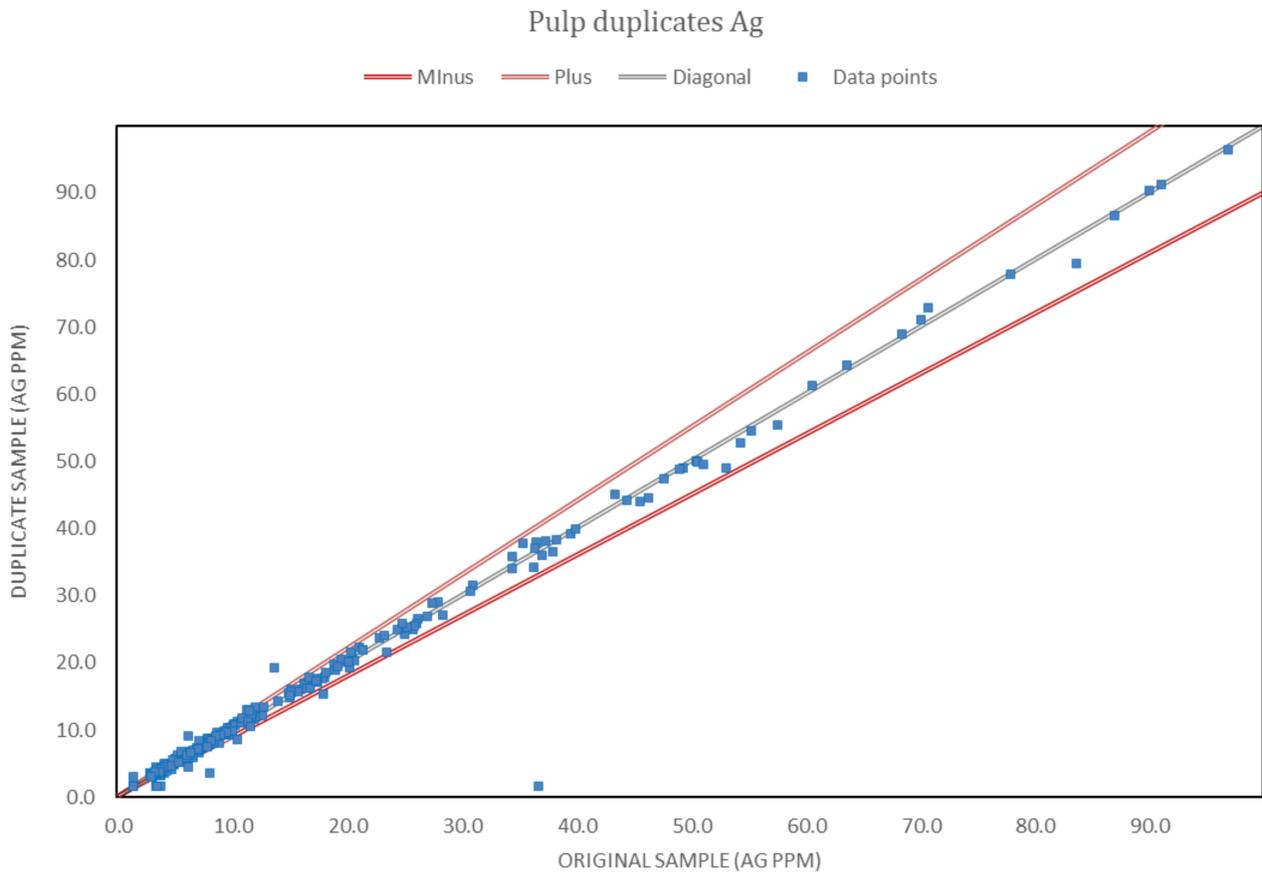
**Figure 11.5 RPD and scatter plot of pulp duplicates Ag – 2014 - 2022**

Note: Scatterplot is limited to 100 Ag ppm.  
Source: PAS (2022).

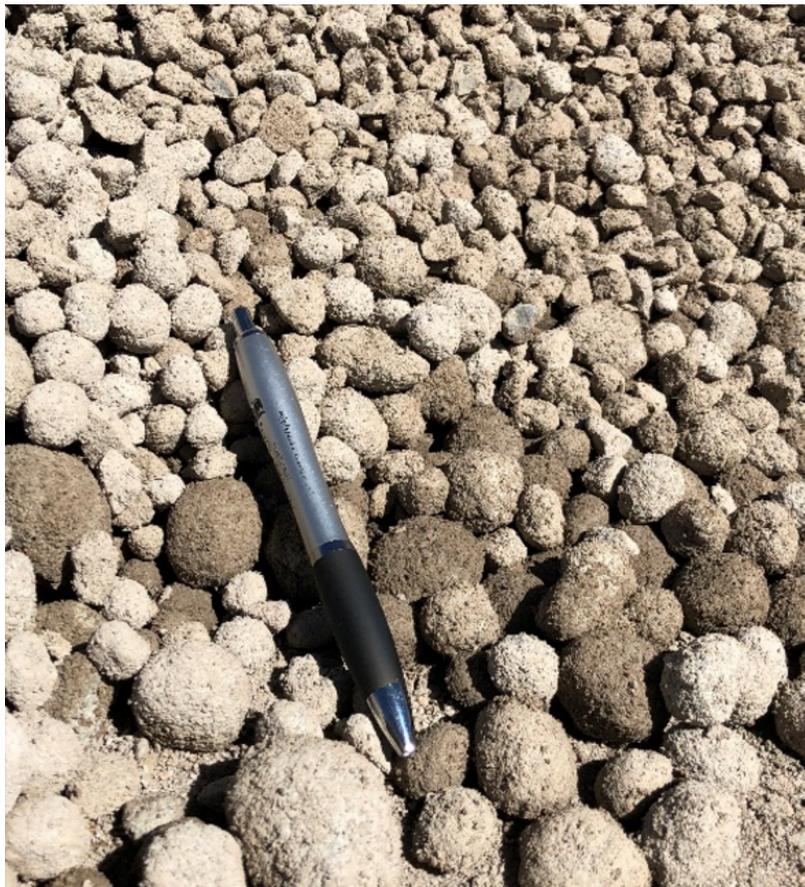
**Figure 13.1** Agglomerates at the heap leach pad

Pulp agglomeration is the process of grinding high-grade ore (pulp), combining with cement, and tumbling to form round balls in the order of 12.5 mm to 25 mm in diameter. In this process, the filtered fine ore, crushed material from the heap leach circuit in ratio 1:1 and cement are tumbled together in a drum at a controlled moisture content and feed rate and begin to stick together, forming agglomerates. The cement acts as a binder to hold the particles together and gives the agglomerates strength to prevent them from crumbling under the weight of material stacked on top of them. This is important to prevent the fine material from being washed into the solution collection drains and to maintain good permeability for percolation of cyanide solution down through the heap. The agglomerates remain very porous, and the increased surface area of the ground particles allows for better contact of the cyanide solution on the surface of the precious metal-bearing minerals. This in turn results in increased metallurgical recoveries compared to only coarse crushing and heap leaching. A photograph of the pulp agglomerates is shown in Figure 13.1.

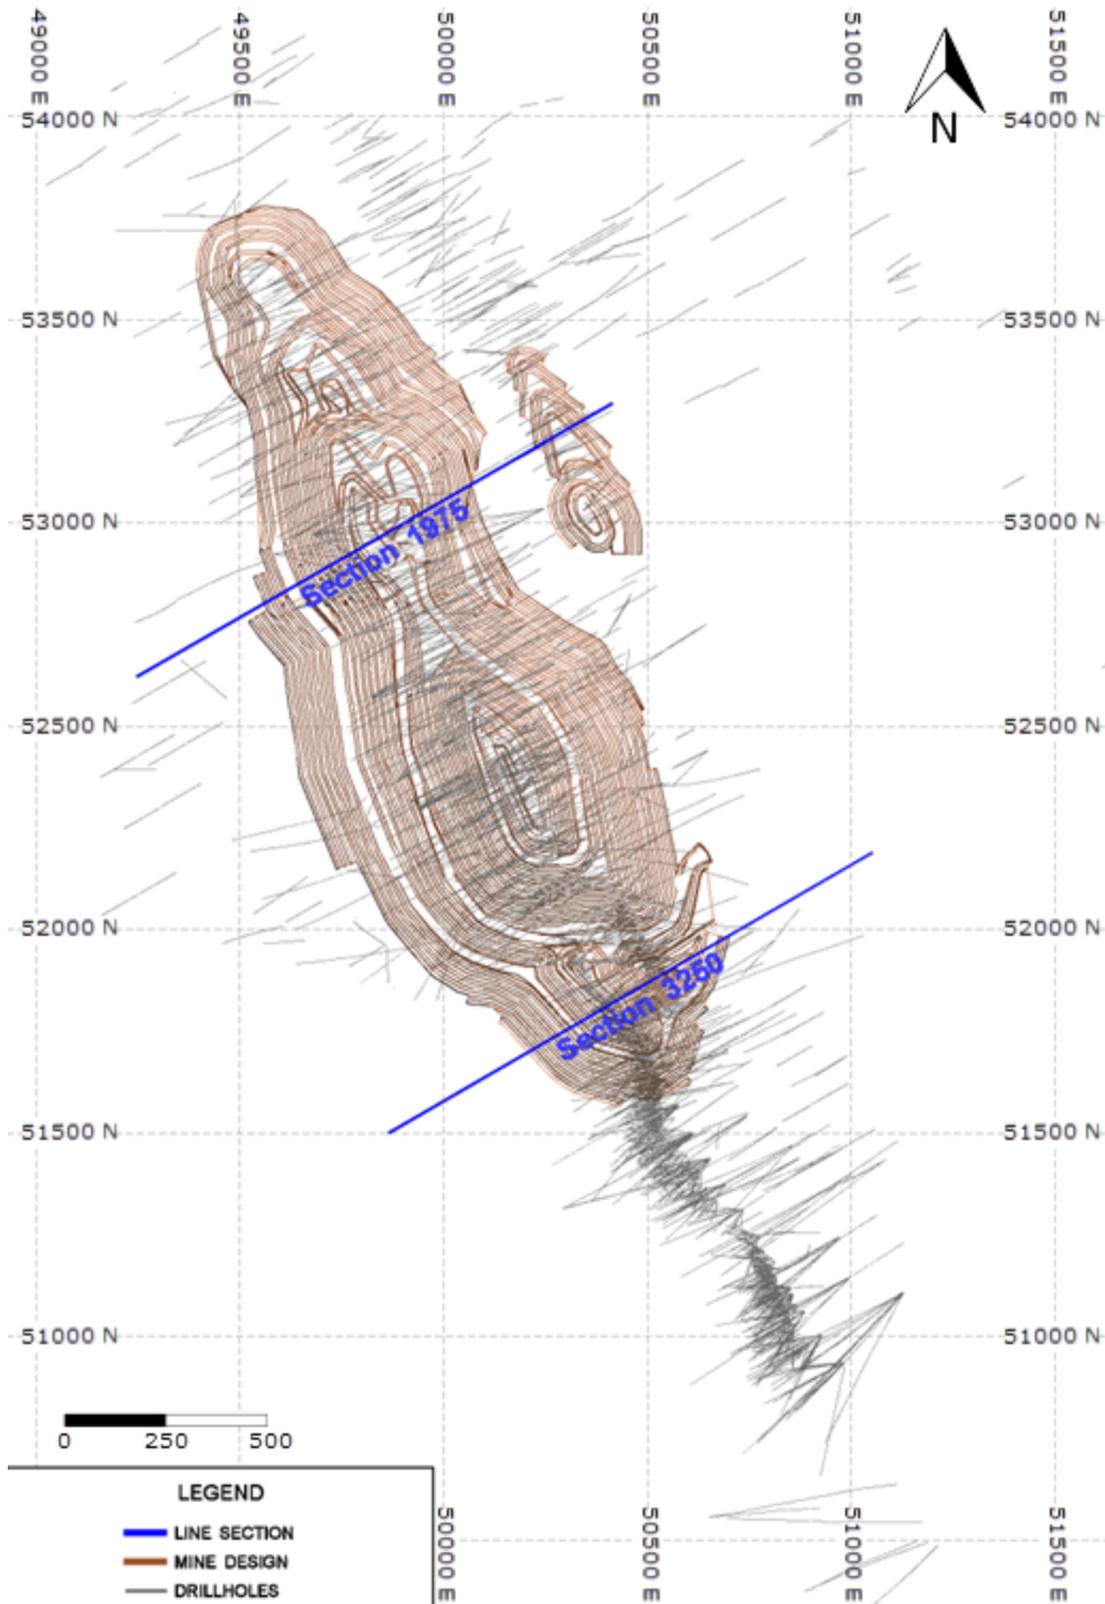
Figure 14.1 Reference plan showing section lines overlain on the open pit outline

A reference plan with section lines overlain on the open pit outline is shown in Figure 14.1. The typical intersection angle to the mineralization and drillhole spacing is shown in cross section in Figure 14.2 and Figure 14.3.

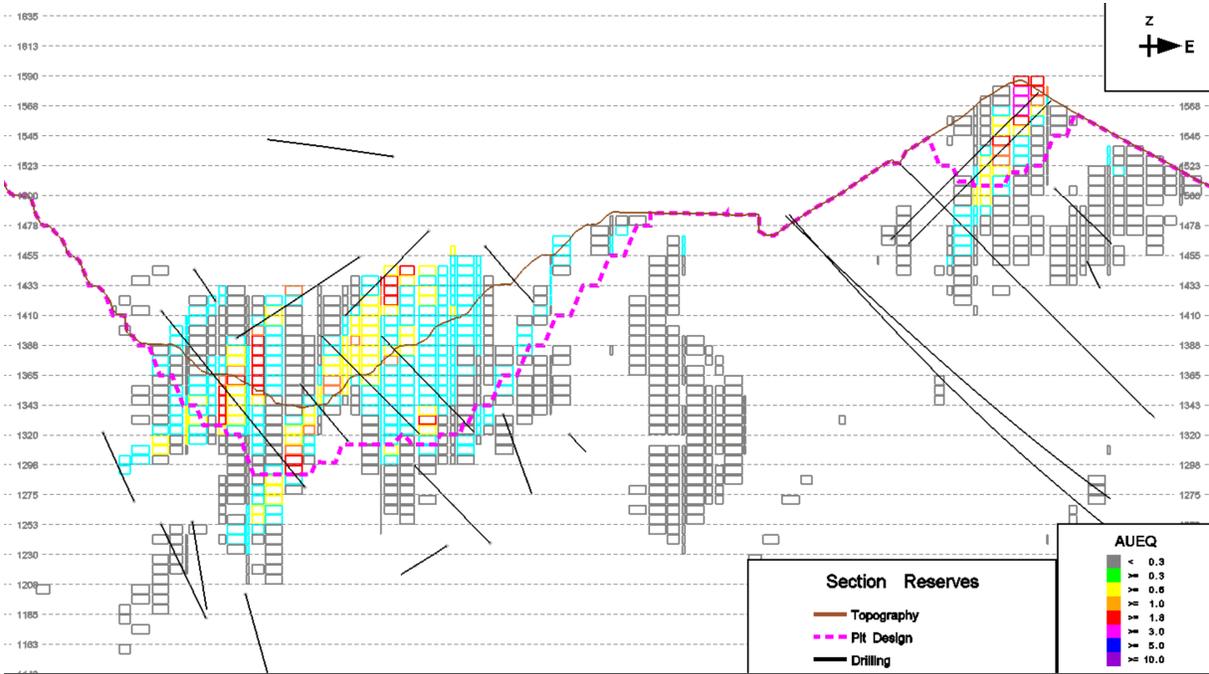
Figure 14.2 Section 1975

Figure 14.2 shows Section 1975, located at the north end of the open pit and Figure 14.3 is a section located at the south end of the open pit and also shows the underground drilling. Both figures show current topography, design reserve pit, block model, and drillholes.
