## **TECHNICAL REPORT FOR THE DOLORES PROPERTY, CHIHUAHUA, MEXICO**

In accordance with the requirements of National Instrument 43-101 “Standards of Disclosure for Mineral Projects” of the Canadian Securities Administrators

Effective date: June 30, 2022

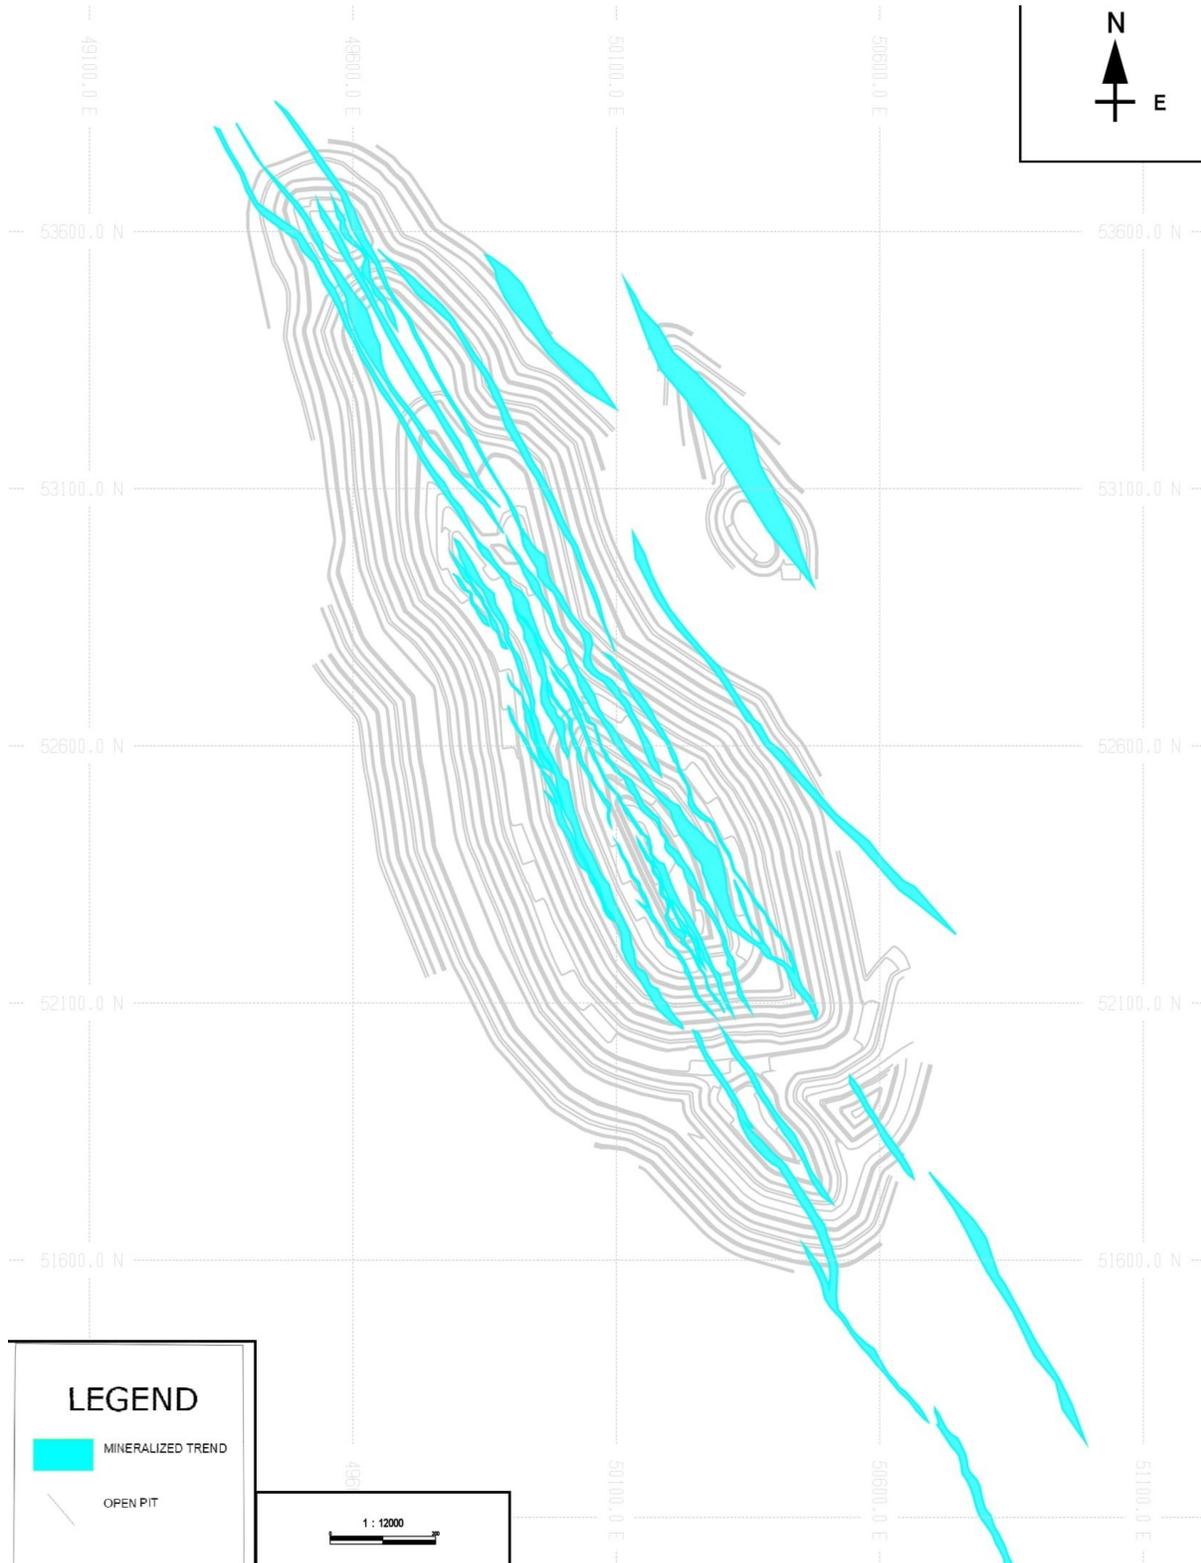
Figure 14.4 Plan of open pit mineralized domains trends

Three dimensional mineralized envelopes for open pit Mineral Resources and Mineral Reserves were prepared around spatially continuous trends of composite samples greater than 0.30 g/t gold equivalent (AuEq), using a gold to silver ratio of 1:70. This resulted in the creation of 28 spatially distinct mineralized trends at four specific areas referred to as San Francisco, Alma Maria, Mid Zone, and the East Dike. These interpretations were wireframed and used to back-code the drillhole data and the block model for these mineralized grade estimation domains, as well as the surrounding unmineralized domain. A plan of the interpreted mineralized trends at the 1,400 m elevation is shown in Figure 14.4. The widths of the narrower zones are in the order of 5 m wide, while the wider zones are in the order of 25 m wide.

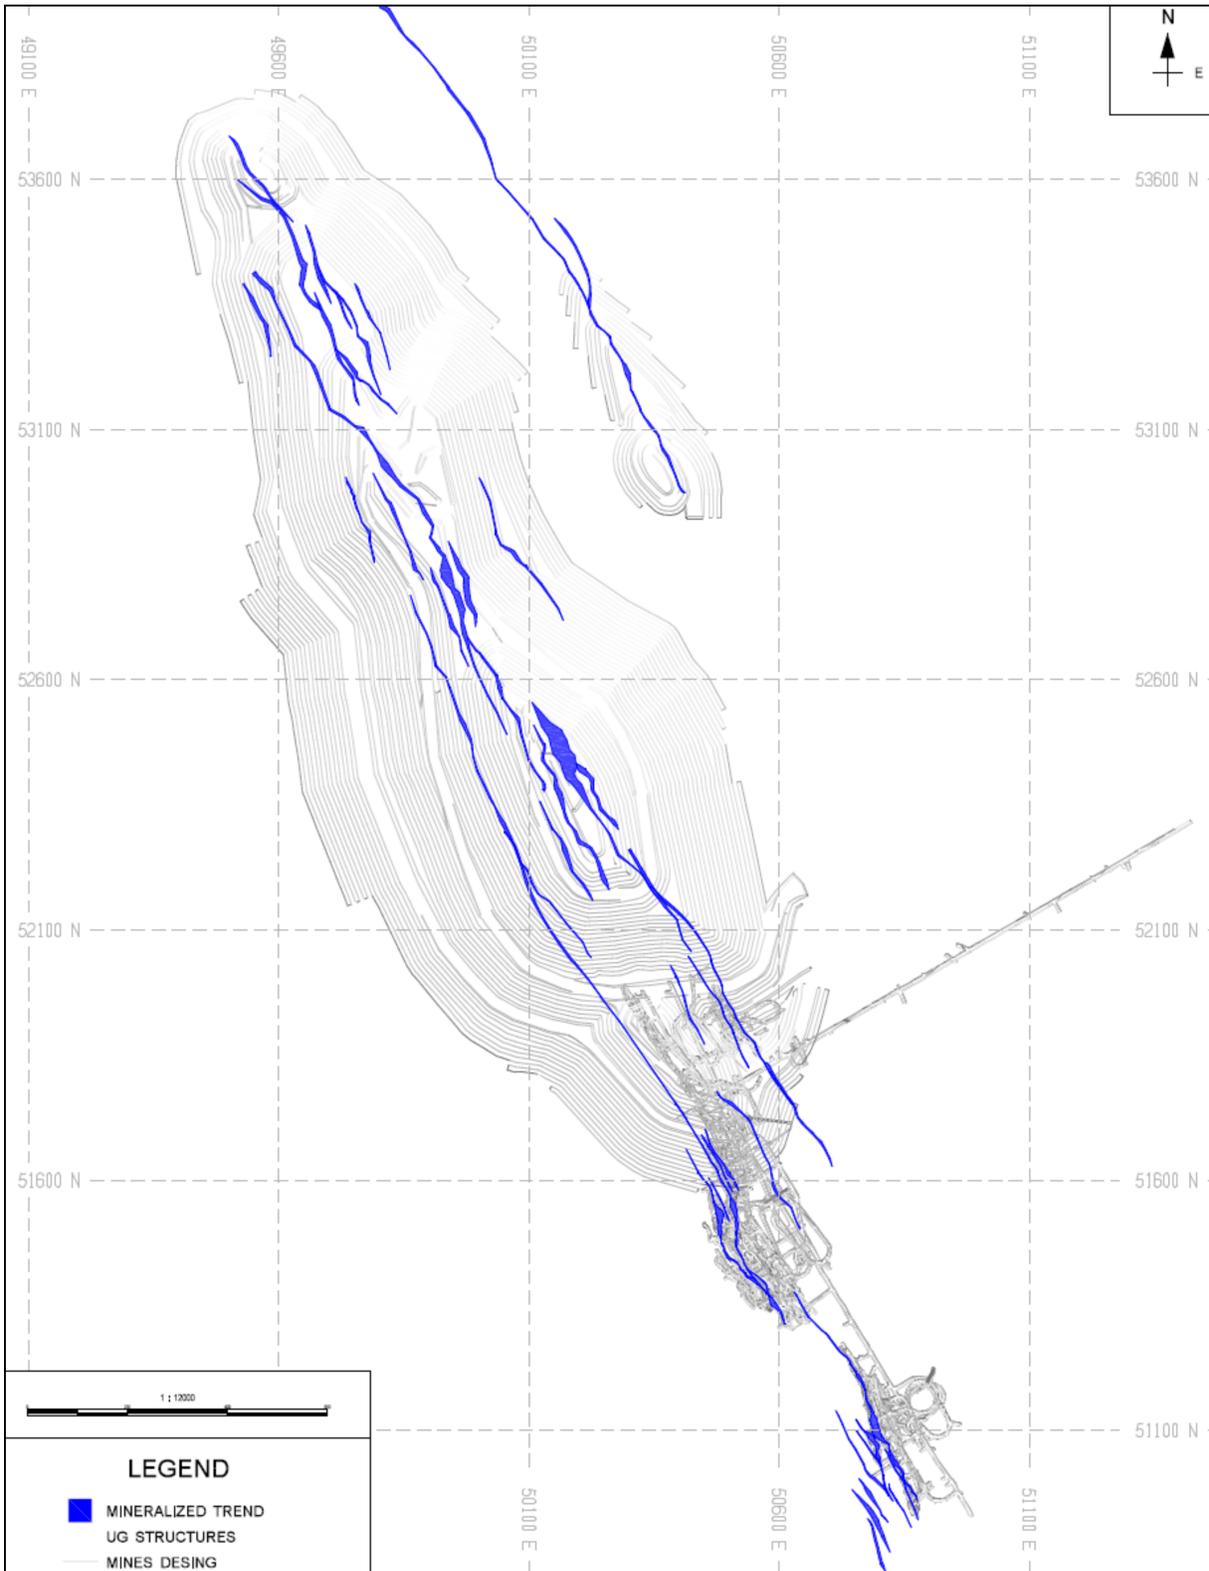
Figure 14.5 Plan of underground mineralized domains trends

Three dimensional mineralized envelopes for the underground Mineral Resources were prepared around spatially continuous trends of mineralization based on composite samples greater than 1.25 g/t AuEq, using a gold to silver ratio of 1:70. This resulted in the creation of 38 spatially distinct mineralized trends at three specific areas referred to as San Francisco, Alma Maria, and the East Dike. These interpretations were wireframed and used to back-code the drillhole data in the same manner as for the open pit. A plan of the interpreted mineralized trends at the 1,400 m elevation is shown in Figure 14.5. The widths of the narrower zones are in the order of 2 - 3 m wide, while the wider zones are in the order of 25 m wide.

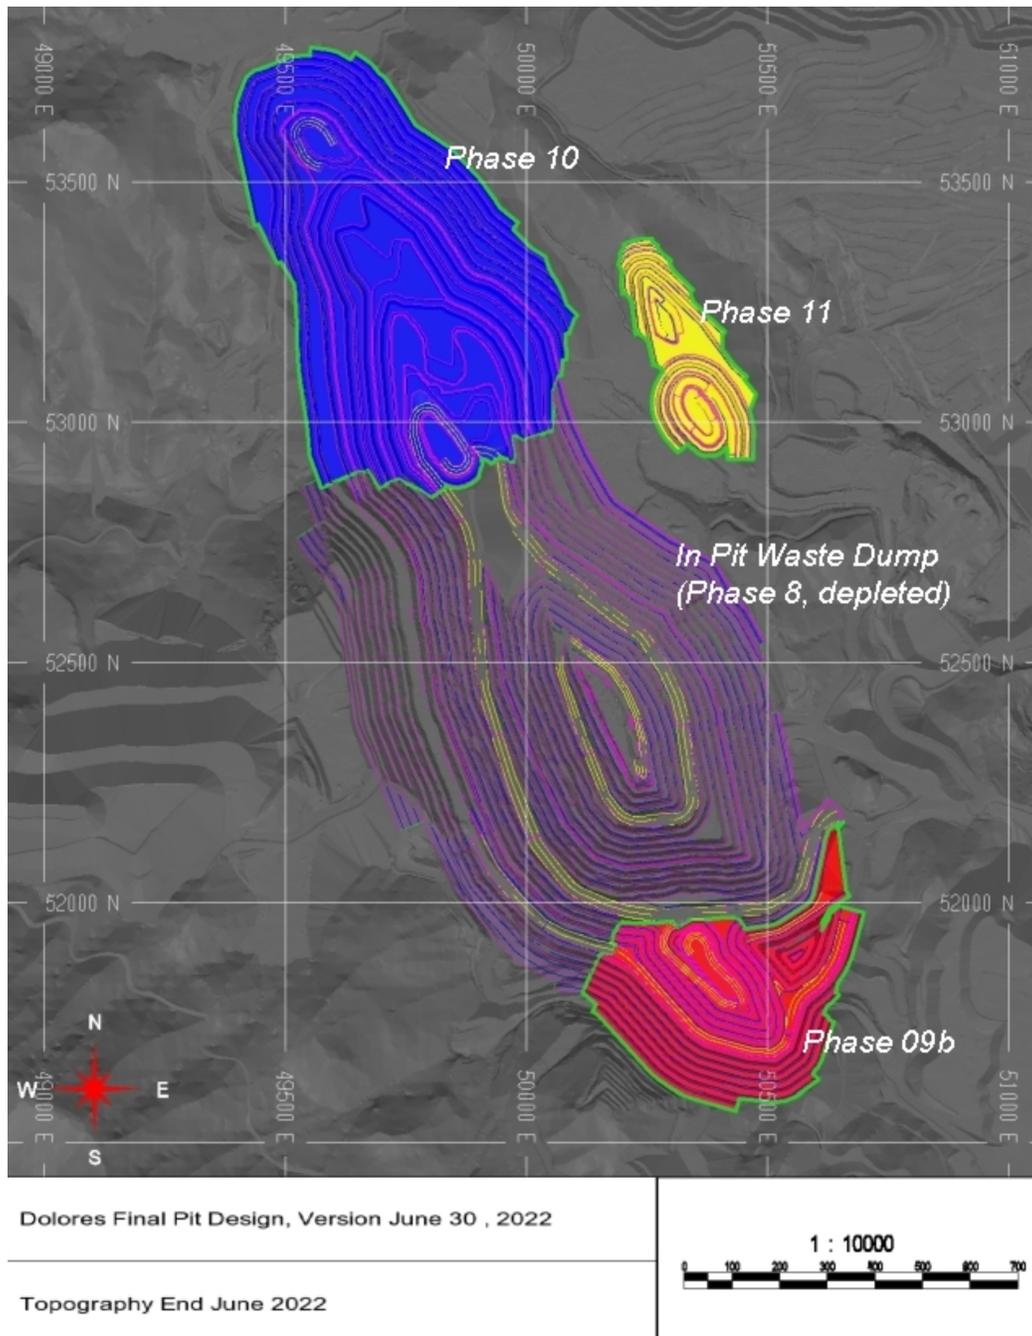
**Figure 15.1 Reserve pit design**

The pit extends around 2,420 m in length trending to the northwest and is about 800 m wide. The deepest part of the pit was depleted in June 2021 and is now used as an in-pit waste dump. Remaining phases at end of June 2022 are at the North, South and East which contain the Mineral Reserves as at end June 30, 2022. A plan view of the ultimate pit is shown in Figure 15.1.

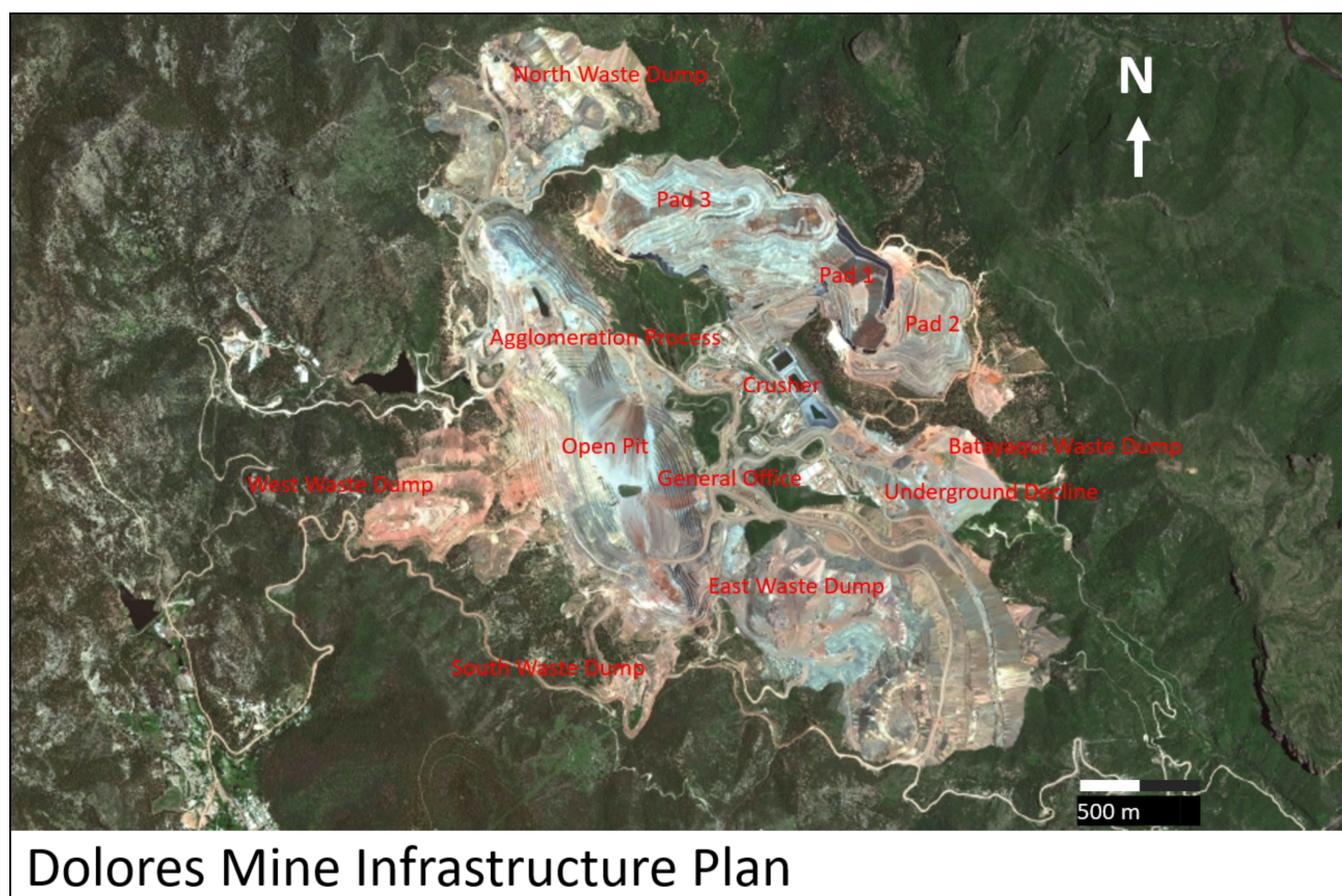
**Figure 18.1** Mine infrastructure plan

A plan of the current site facilities is shown in the photograph in Figure 18.1.
