NI 43-101 TECHNICAL REPORT

MOHAVE GOLD-SILVER PROJECT
MOHAVE COUNTY, ARIZONA, USA

Kingman Minerals Ltd.

Effective Date: November 10, 2025

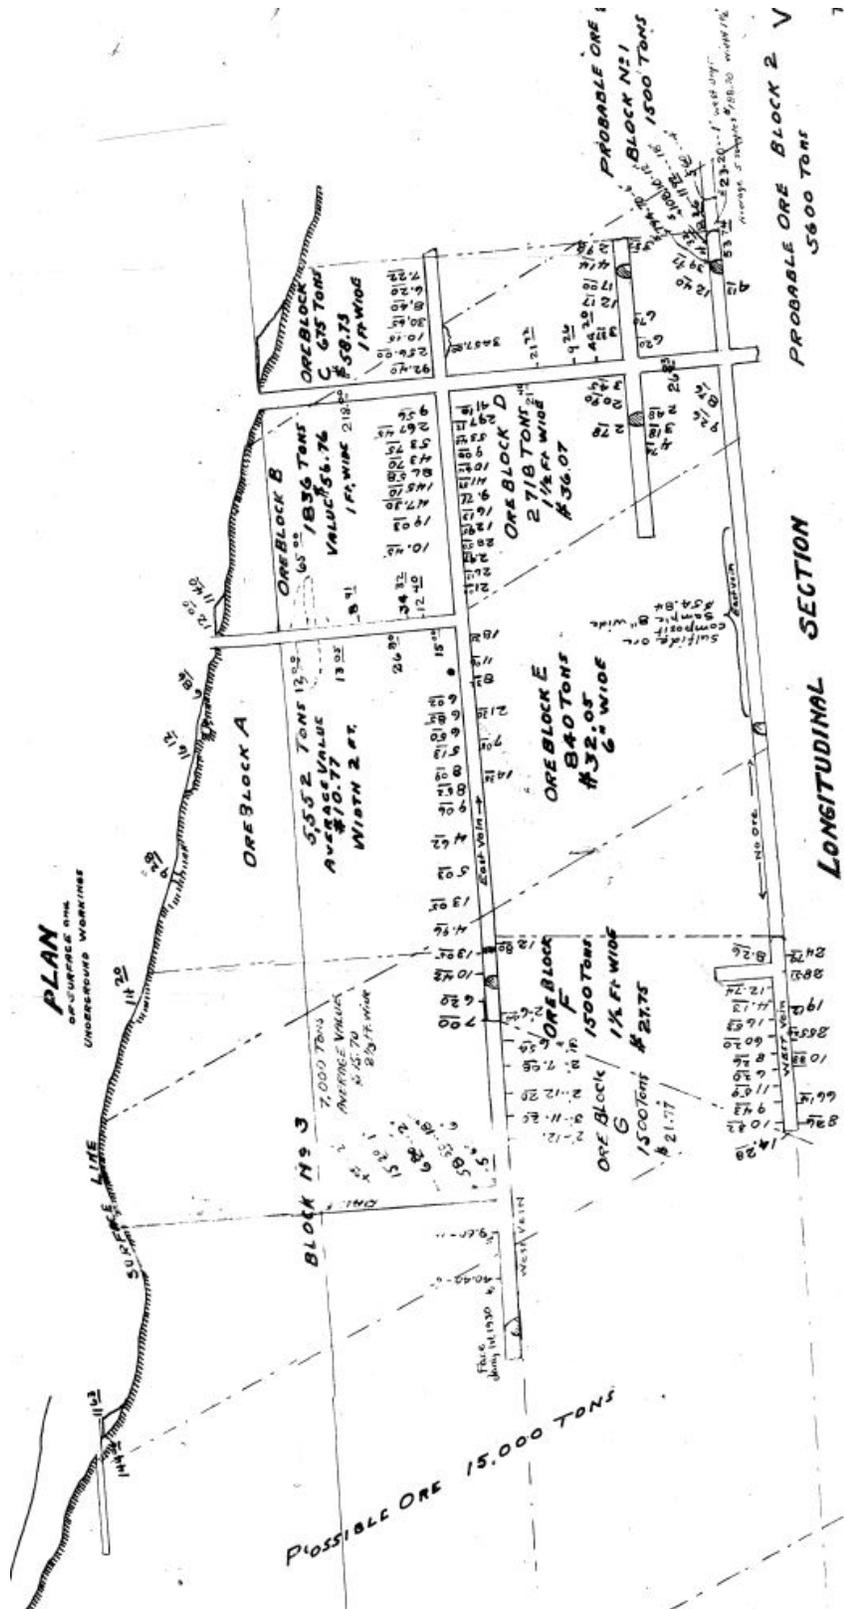
Figure 6.1 - A portion of Jacobson's (1928) longitudinal section.

The graphic in Figure 6.1 also defines Jacobson's "ore blocks" A – F and 1 – 3. These "ore blocks" are not considered ore by the Author or Kingman Minerals. The Author has no way to determine how the blocks were measured or assayed, they were calculated before NI 43-101 and did not use the current mineral resource and mineral reserve classifications established by the Canadian Institute of Mining, Metallurgy and Petroleum (CIM).

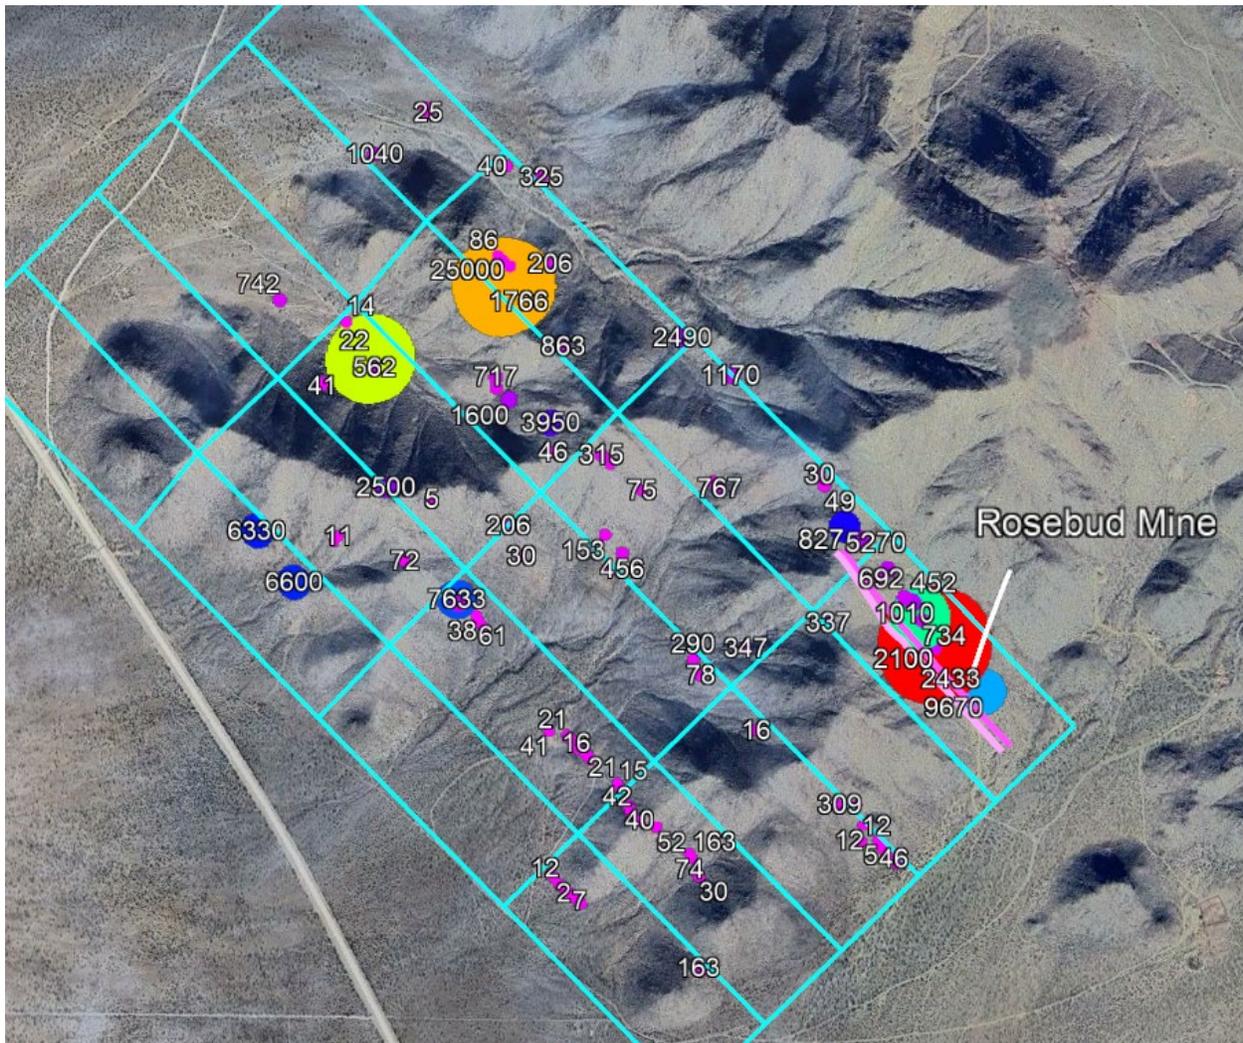
Figure 6.2 - Bubble plot of Au ppb values from Harrington's 2005 technical report.

samples were collected and analyzed. Of these samples, thirty-five (26%) returned values greater than 500 ppb Au. The results of the surface sampling were listed in Appendix B of Harrington's report along with the assay certificates from International Plasma Laboratories in Vancouver, BC. The Author was able to plot the sample locations from Harrington's map with approximate accuracy using Google Earth. Multiple elements were analyzed. Figures 6.2 and 6.3 are bubble plots of Au in ppb and Ag in ppm, respectively, with accompanying analytical values. They show the widespread nature of Au and Ag mineralization across the property.

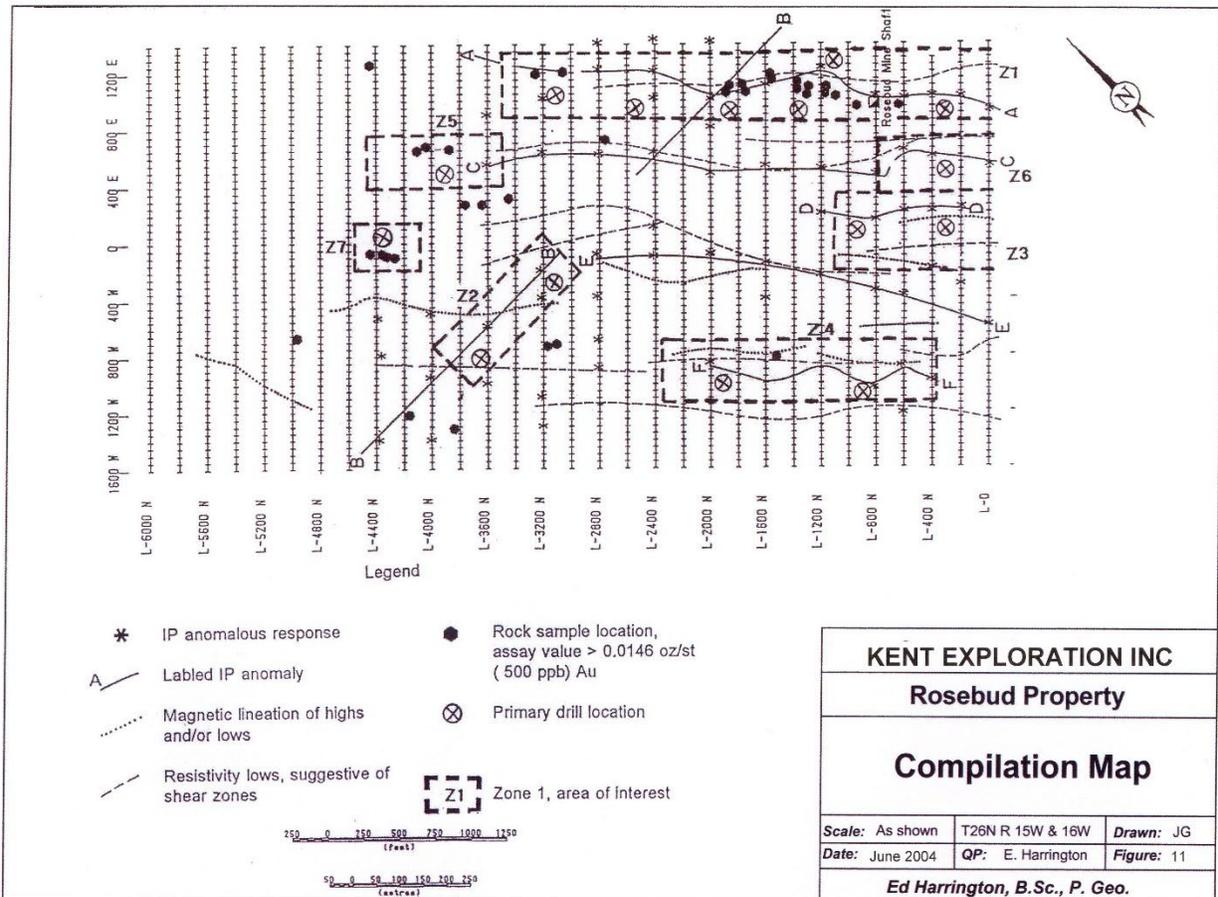
Figure 6.4 - Compilation of data from the 1995 programs discussed in Harrington (2005).

A geologic map of the entire property was included in the report, along with results of the geophysical surveys. Data from the 1995 program were summarized in Figure 5.2 which defined seven target areas, Z1 through Z7, for future exploration work. This additional work was never completed.

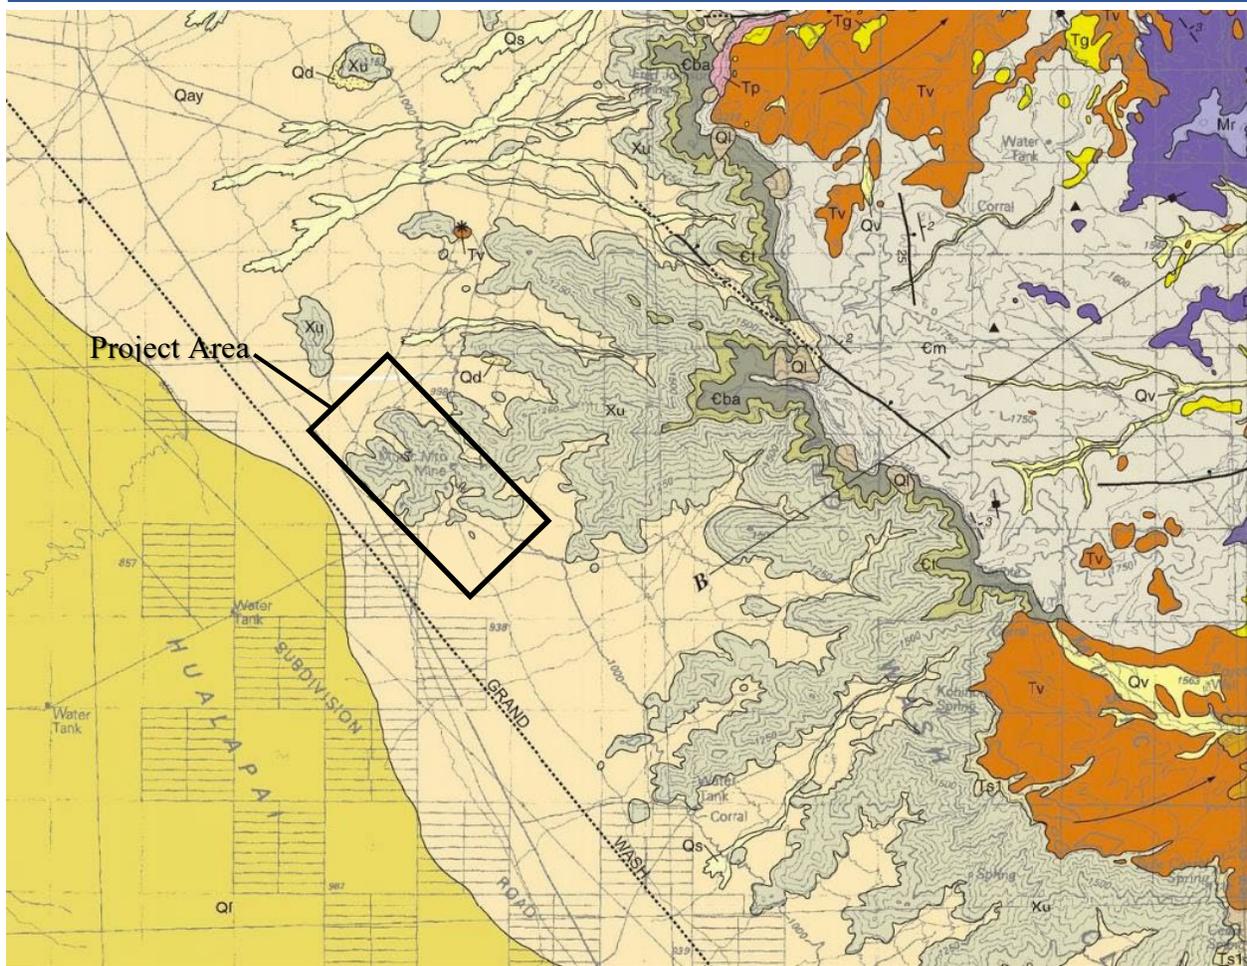
Figure 7.1 is a portion of the Peach Springs 30' X 60' geologic map (Billingsley et al, 2006). It shows the Hualapai Valley Quaternary sediments to the southwest of the property and the Paleozoic Grand Wash Cliffs to the northeast.

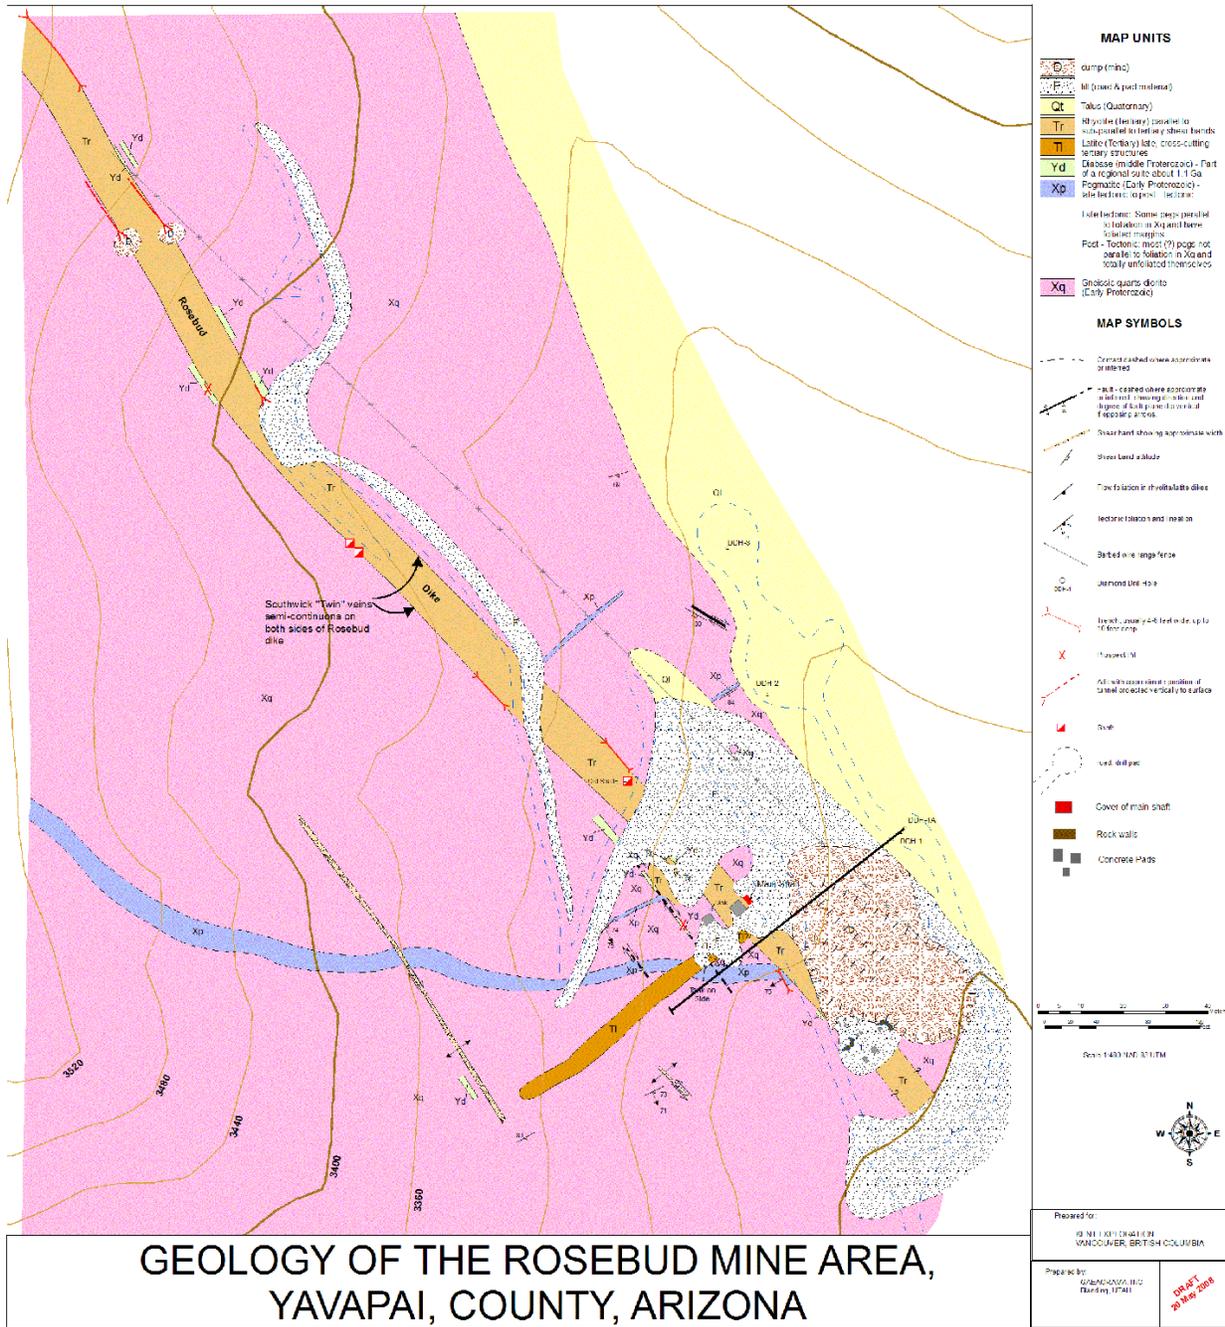
Figure 7.2 - Geologic map of the Rosebud Mine and vicinity.

A portion of Conway’s (2008) map is shown as Figure 7.2. Conway told the QP that the map was not completed due to budget considerations (personal communication, 2020), but it remains the best-detailed geologic map of the area surrounding the Rosebud Mine. Conway or his draftsman was apparently confused about which county the property is located, as the map mistakenly represents it as being in Yavapai County. A short report, which was also not completed, was also made available.

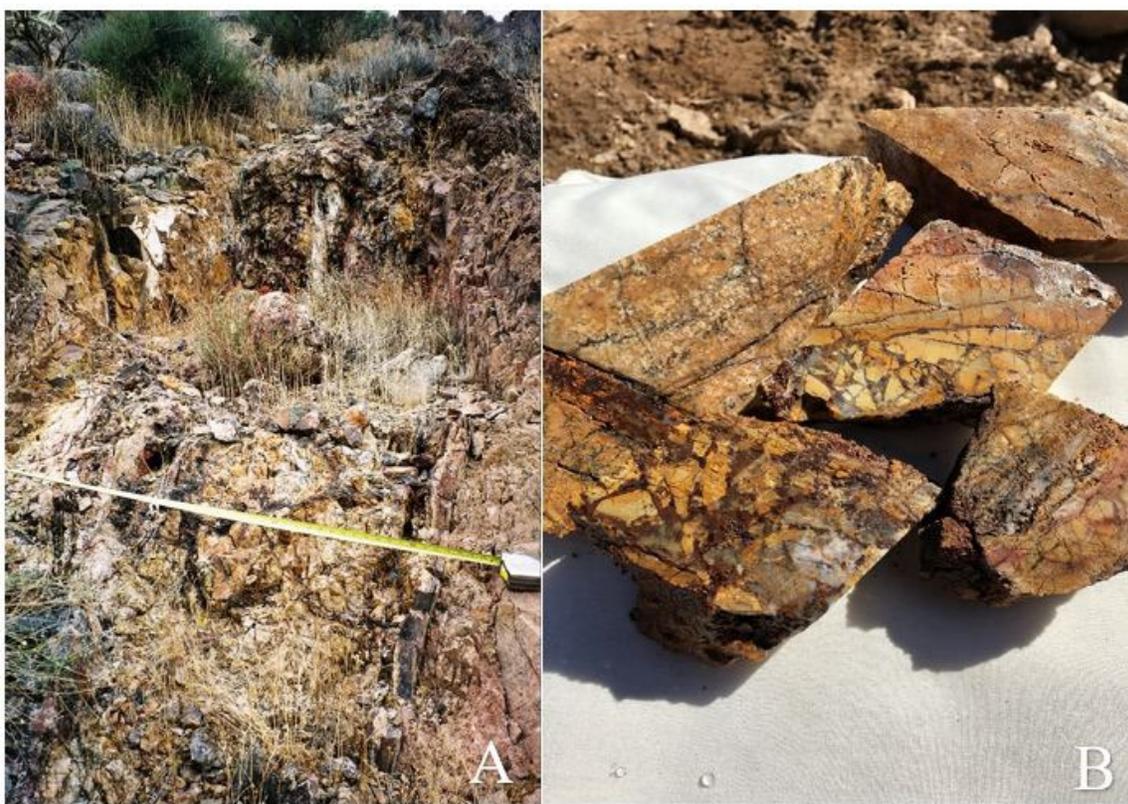
Figure 7.3 - Oxidized vein material in outcrop (A) and in core (B) – Brecciated vein material from drill hole MH-03.

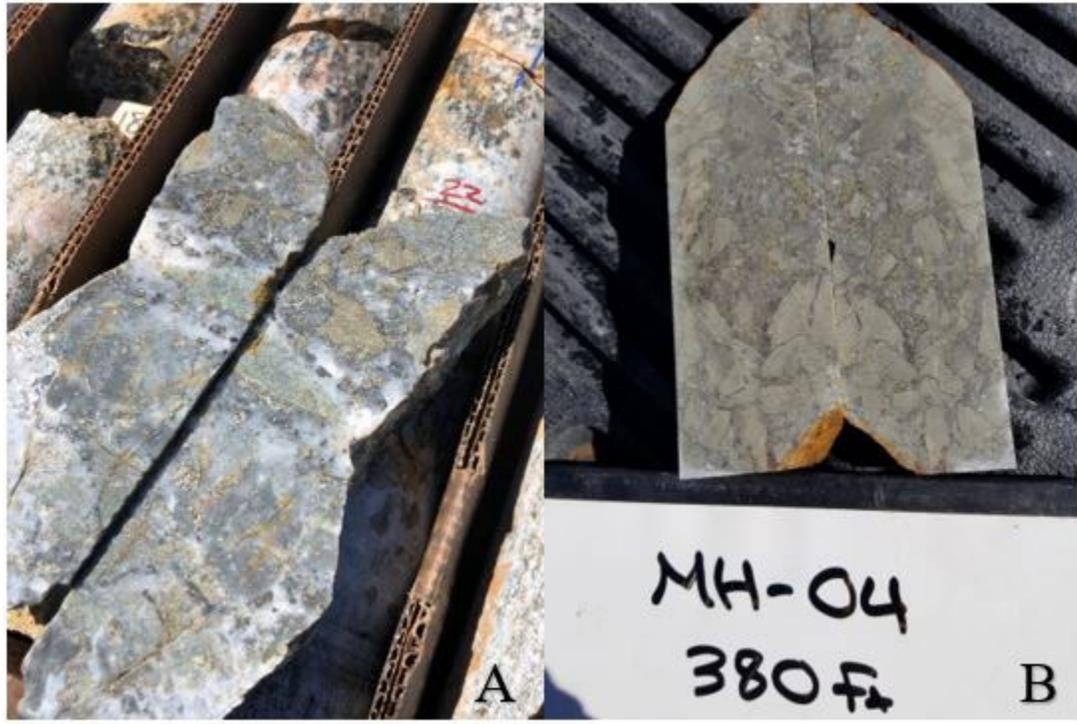
Figure 7.4 - Examples of unoxidized sulfide vein material (A - MH-03)(B - MH-04).

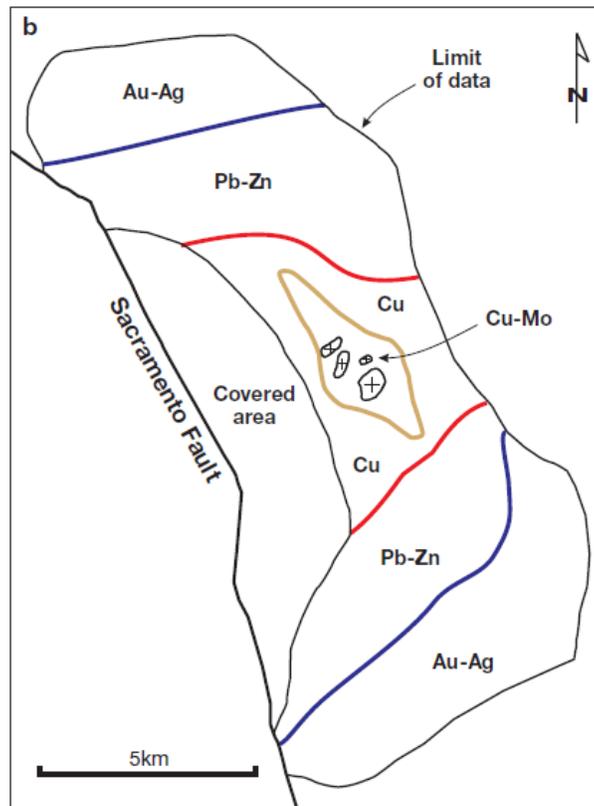
Figure 8.1 - Metal zoning at Mineral Park (Sillitoe, 2010, Fig. 9b).

As with many porphyry copper-molybdenum systems, Au and Ag veins are the outermost manifestations of the overall system at Mineral Park, as displayed in Figure 8.1 from Sillitoe (2010).

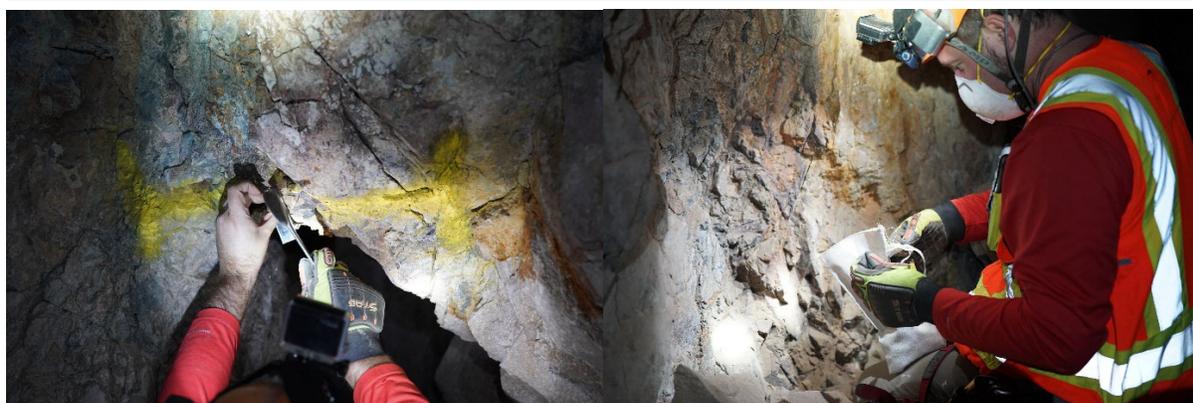
Figure 9.1 - Examples of underground sampling photos.

Burgex Mining Consultants performed two underground surveys of the Rosebud mine. The first one was on February 12, 2020. Using ropes and climbing gear, they were able to access the mine's 100-foot level and collect 17 samples for assay. They also recorded photographs and videos of the mine workings and sample locations. Examples of photographs from the 100-foot level sampling are shown in Figure 9. 1. Sample results are shown in Table 9.2.

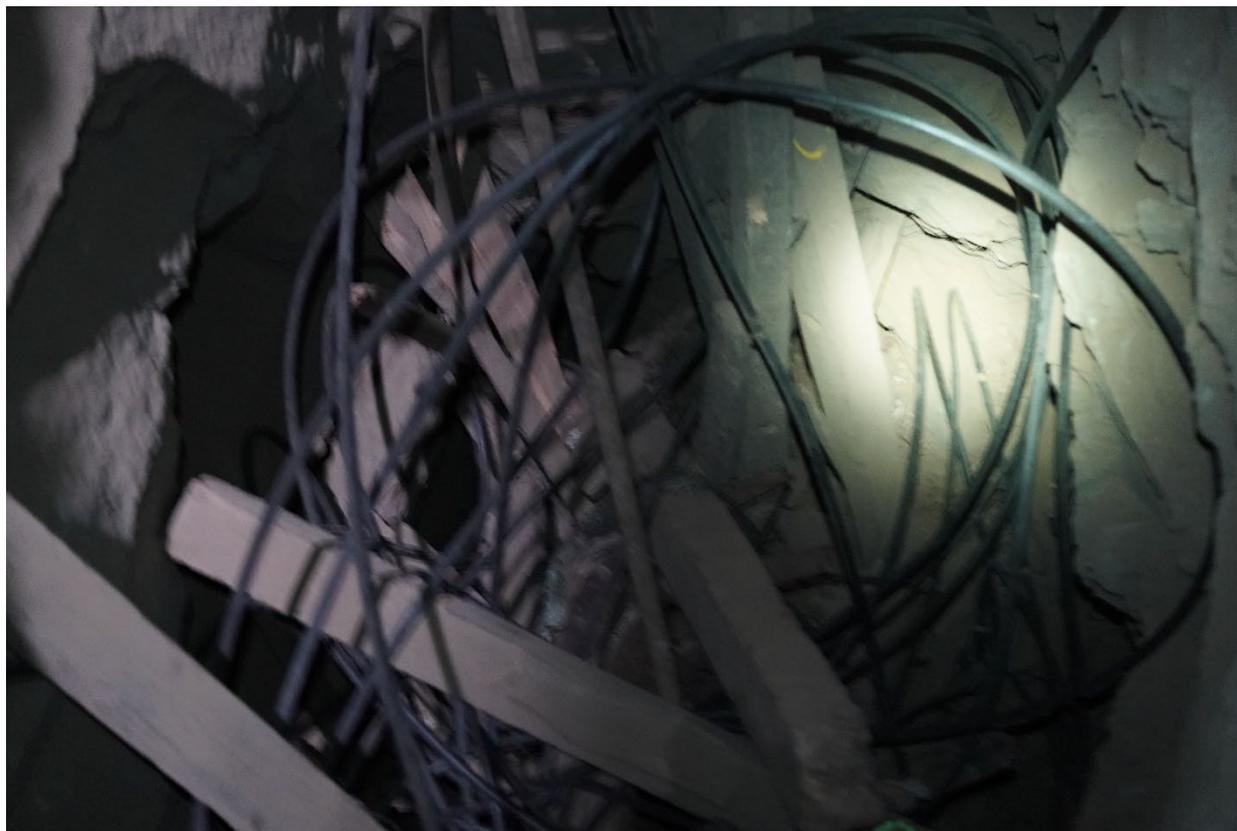
Figure 9.2 - Blockage of the Rosebud shaft below the 200-foot level.

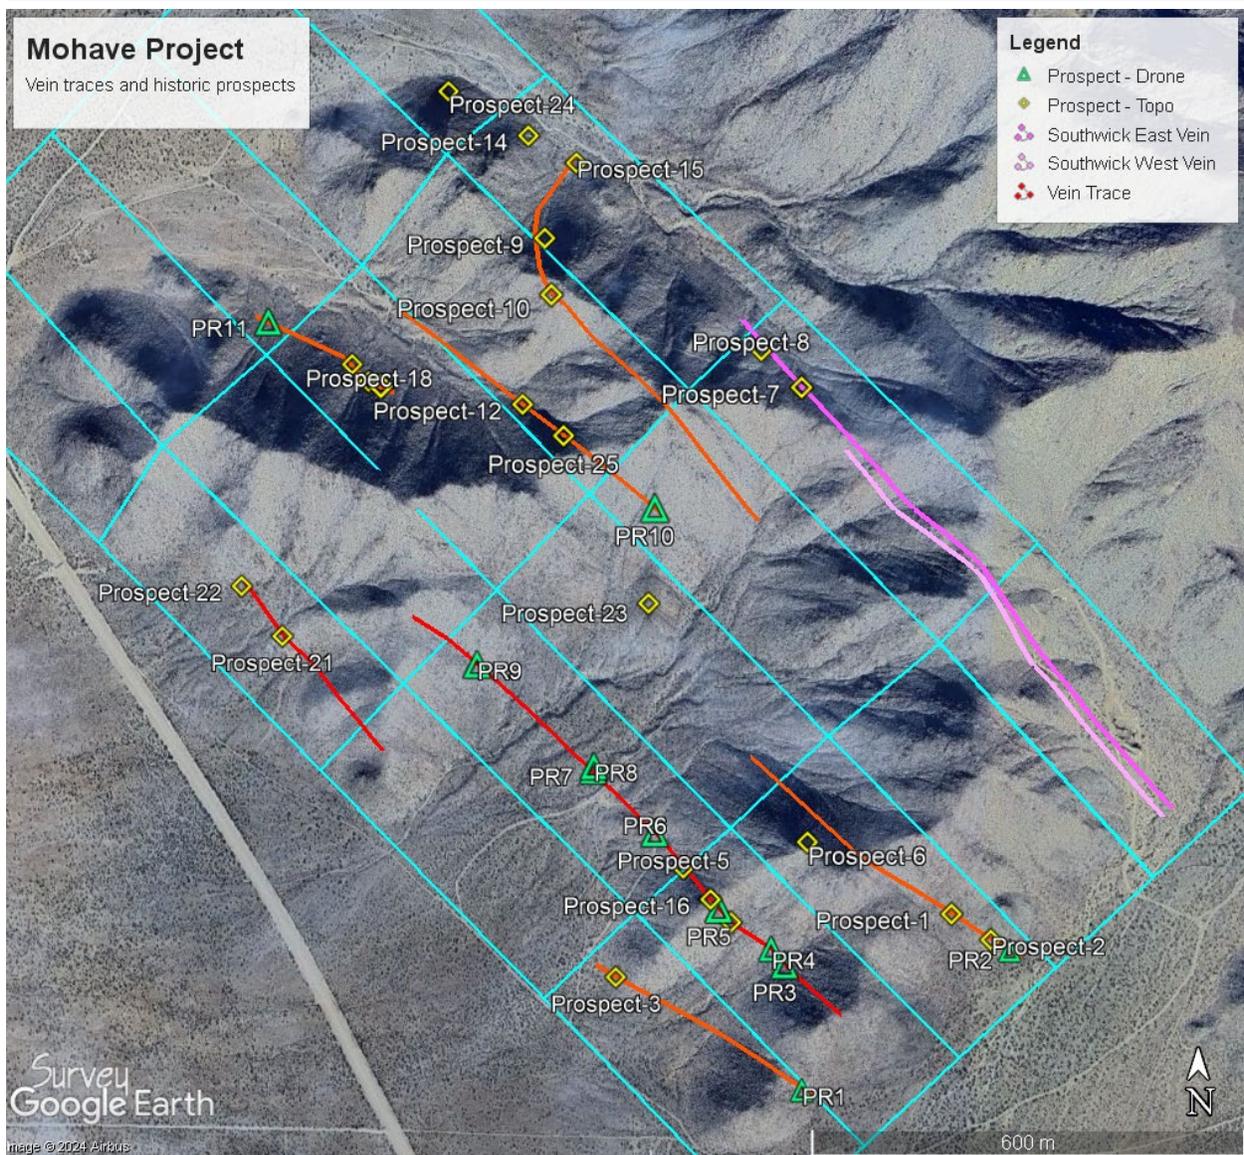
Figure 9.3 - Veins traced from drone photos.

In addition to the underground work completed by Burgex Mining Consultants, they performed a drone survey for Kingman that provided high resolution aerial photos and topography. Using the Burgex photo mosaic, it was possible to trace several mineralized structures across the property and locate many additional prospect pits and trenches. Figure 9.3 is an image showing the vein and prospect locations found on the drone mosaic after transposing them into Google Earth. Also shown, are the original 20 Rosebud claims, the traces of the Southwick veins at surface, and other prospects located from the USGS topo map.

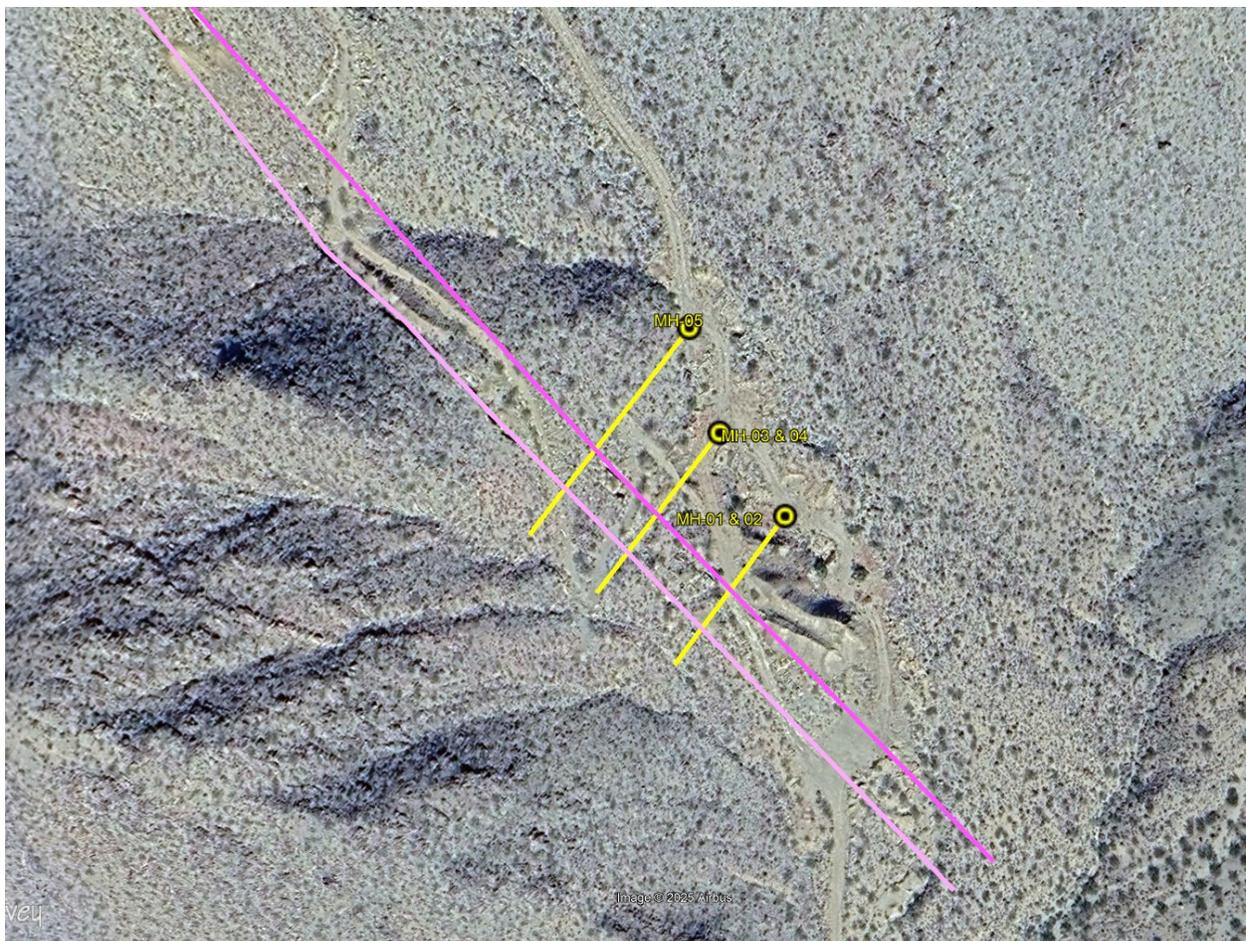
Figure 10.2- Southwick vein traces and Phase I drill holes.

Figure 10.2 is a 3D representation of the 5 Phase I drill holes. The main shaft and mine workings are represented by other colored cylinders. The mine workings depicted in Figures 10.1 and 10.2 were traced from historic mine maps. The drill hole collars were located using a handheld GPS. All holes received down-hole surveys to detect the amount of drift from their intended direction.

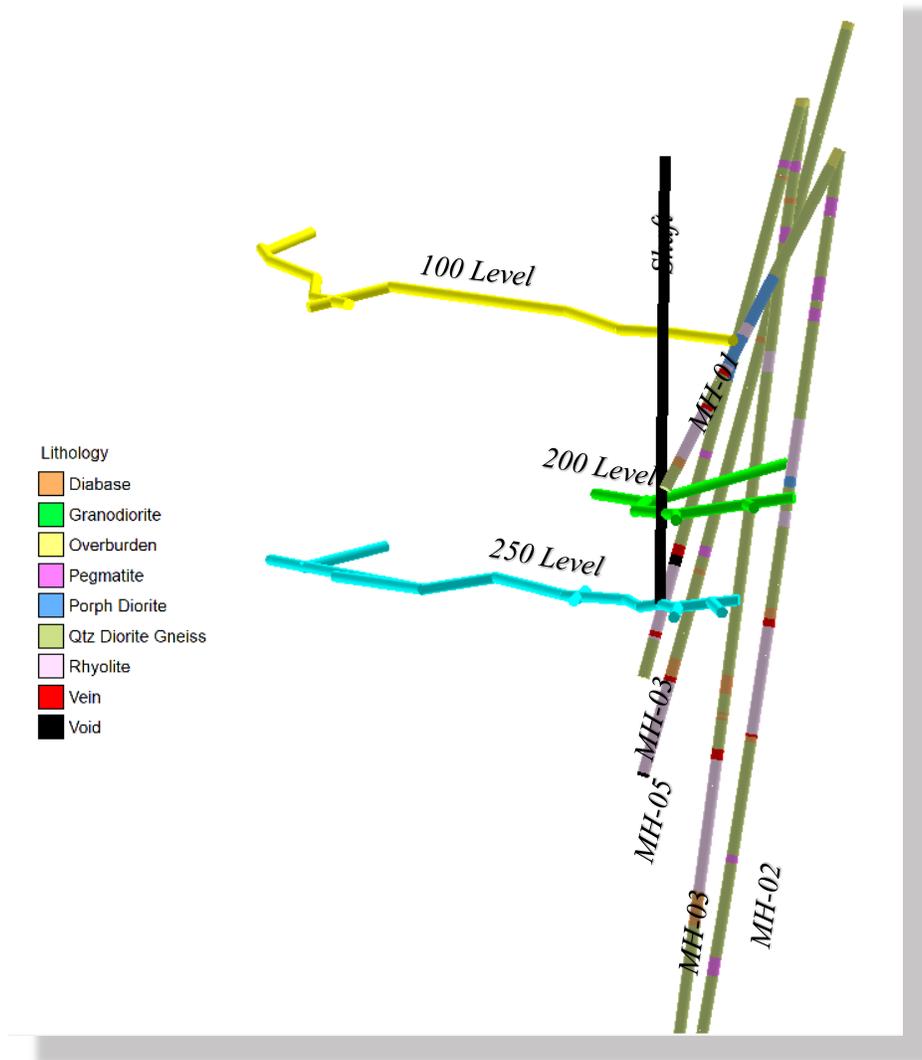
Figure 10.3 – A 3D representation of the Phase I drill holes and mine levels looking approximately north.

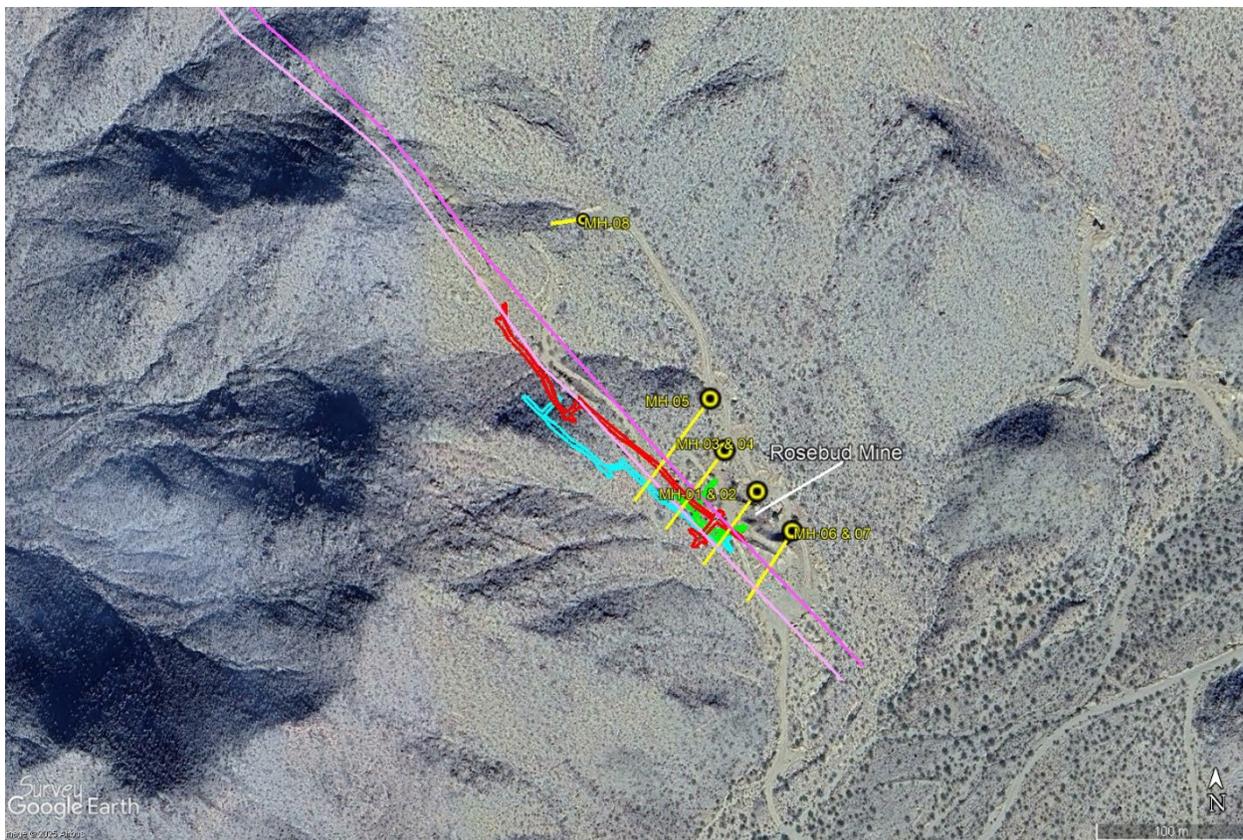
Figure 10.4 - Image of the drill hole locations, veins and the Rosebud mine levels.

Figure 10.3 is a Google Earth image with the locations of all of the Phase I and Phase II holes. It also shows the surface traces of the Southwick veins (Pink) and the approximate locations of the underground workings (100-foot level in Red, 200-foot level in green and 250-foot level in Blue).

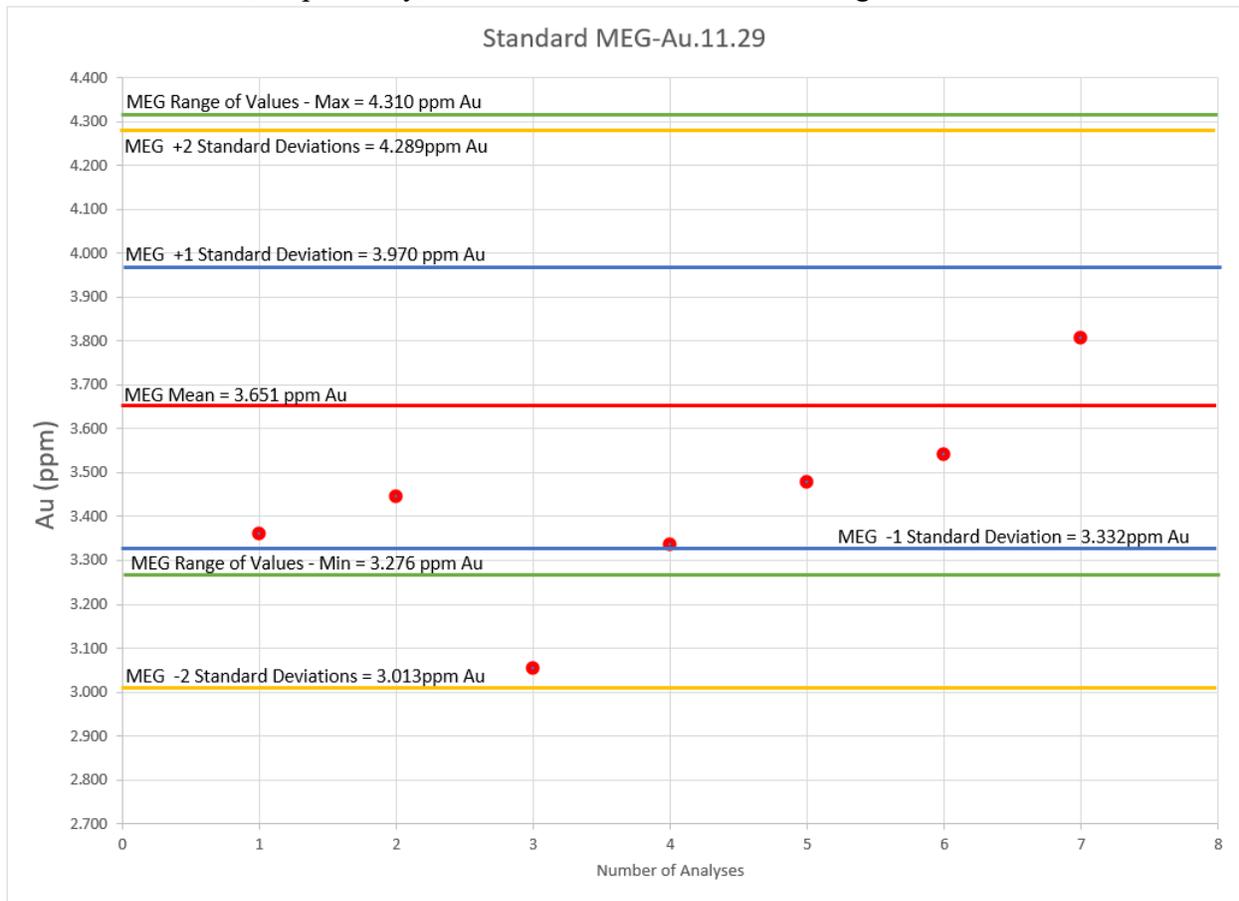
Figure 11.3 - Plot of MEG-Au.11.29 reference standard assay values.

Figures 11.3 and 11.4 are plots of the assay results for the 7 MEG-Au.11.29 and MEG-Au.17.09 reference standards, respectively, used in the Phases I and II drilling.

All but one value for each standard are somewhat on the low side of each standard's mean, but all but one value for MEG-Au.17.09 were within 2 standard deviations of the mean for each standard. All assays of Blank reference materials returned at, below or just barely above Detection Limit values. These were deemed by the Author to be acceptable results for this stage of the project.
