NI 43-101 TECHNICAL REPORT

MOHAVE GOLD-SILVER PROJECT
MOHAVE COUNTY, ARIZONA, USA

Kingman Minerals Ltd.

Effective Date: November 10, 2025

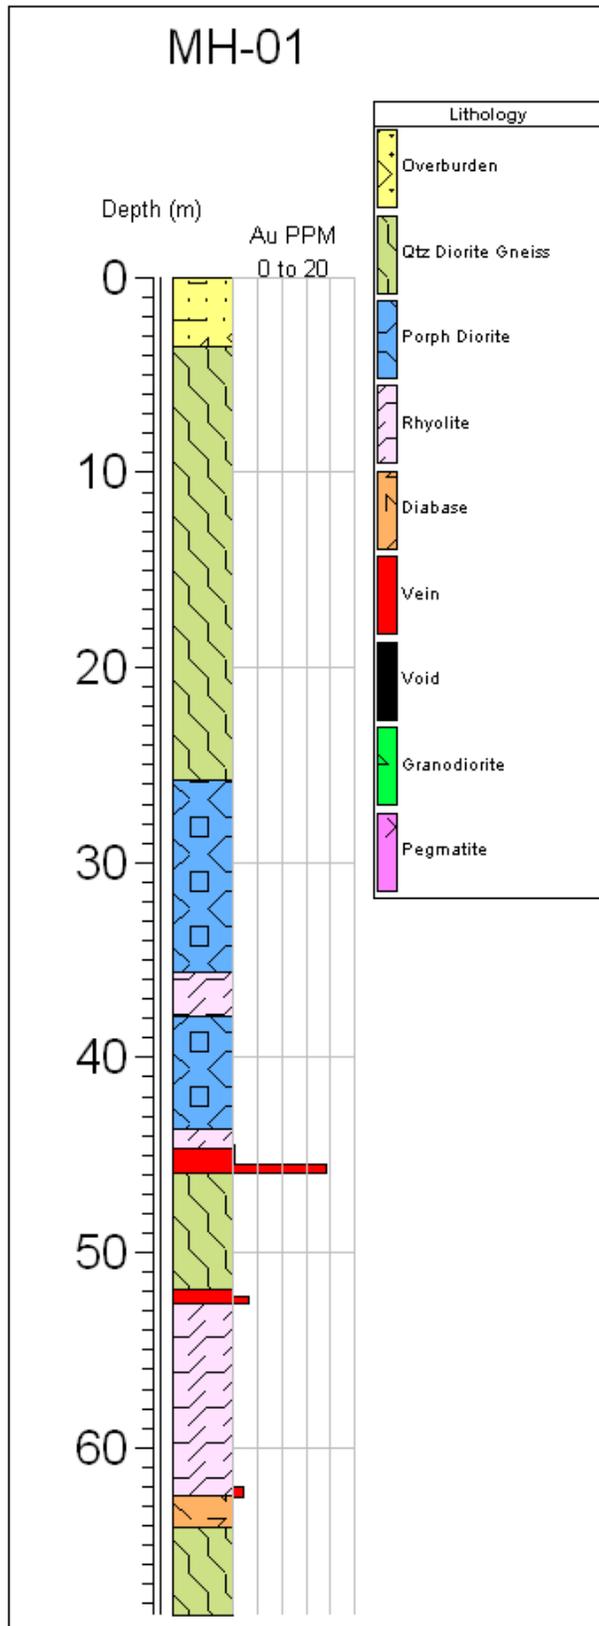
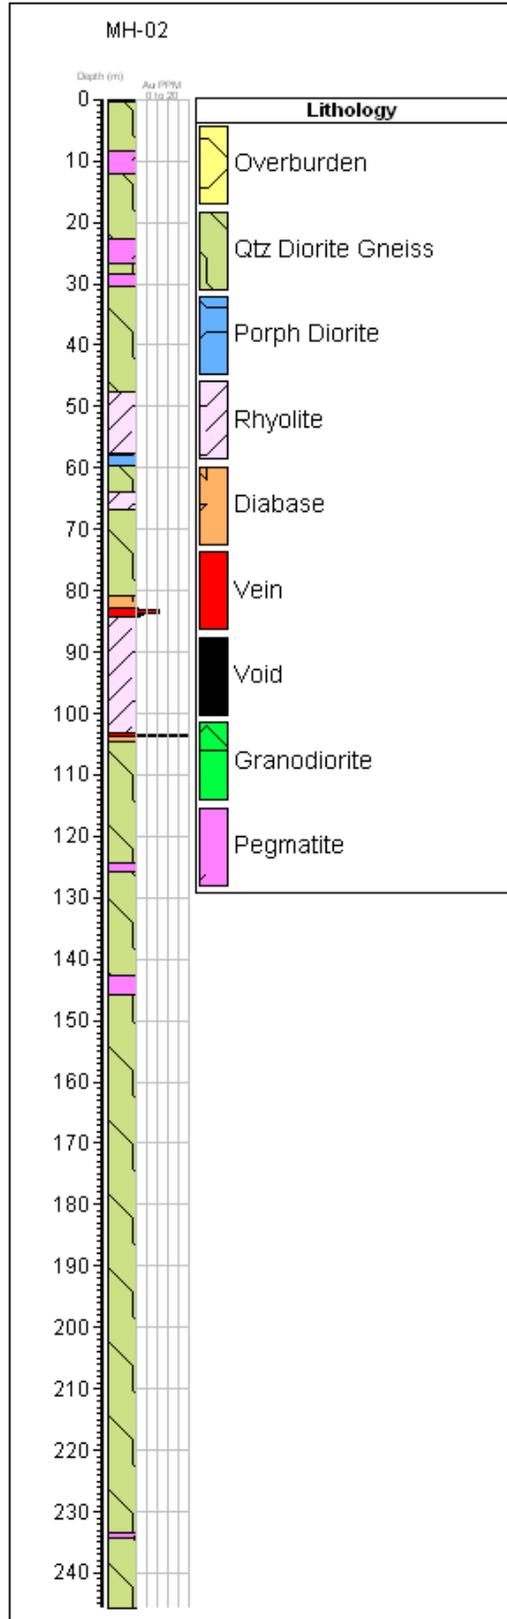
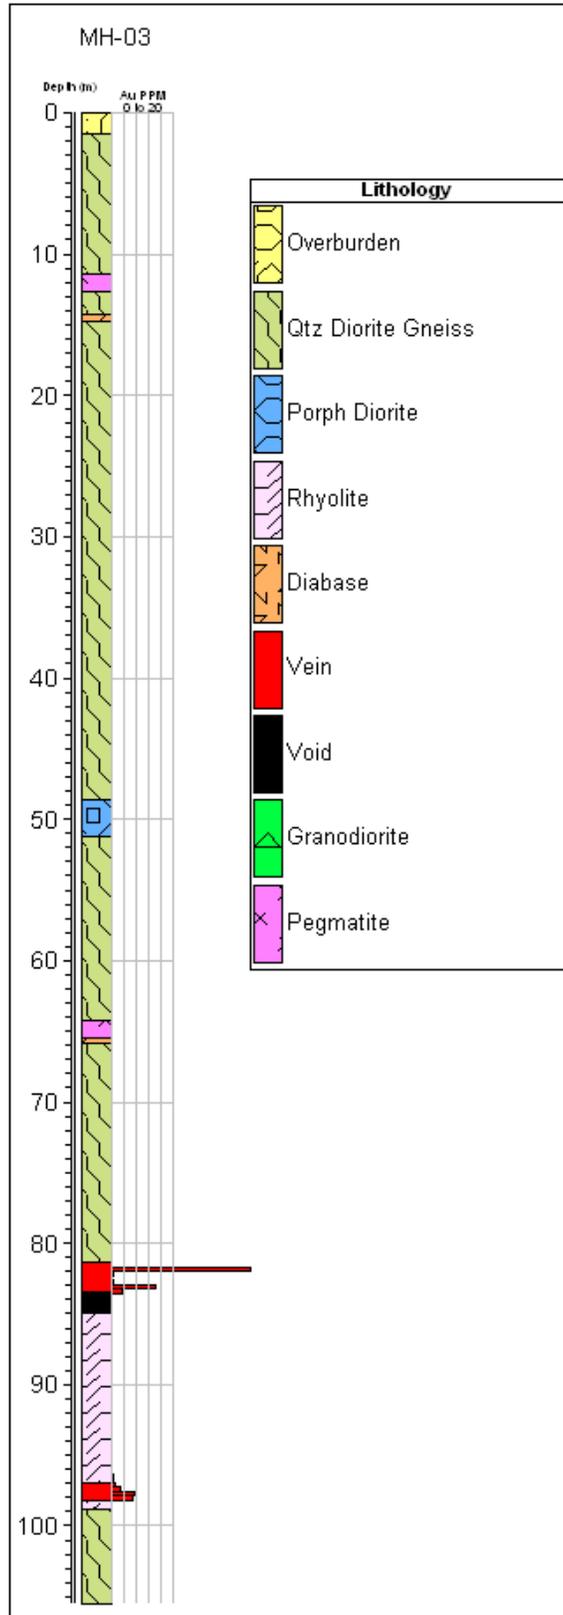
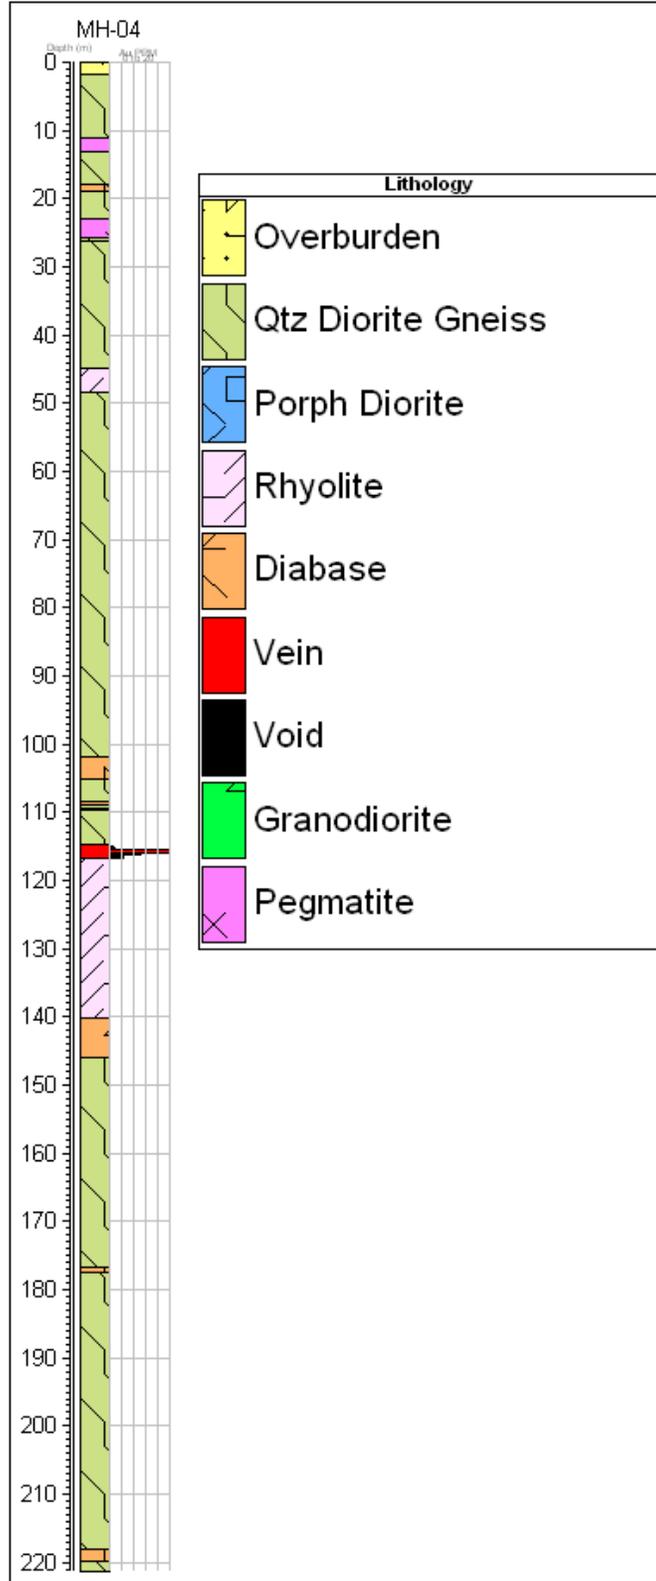
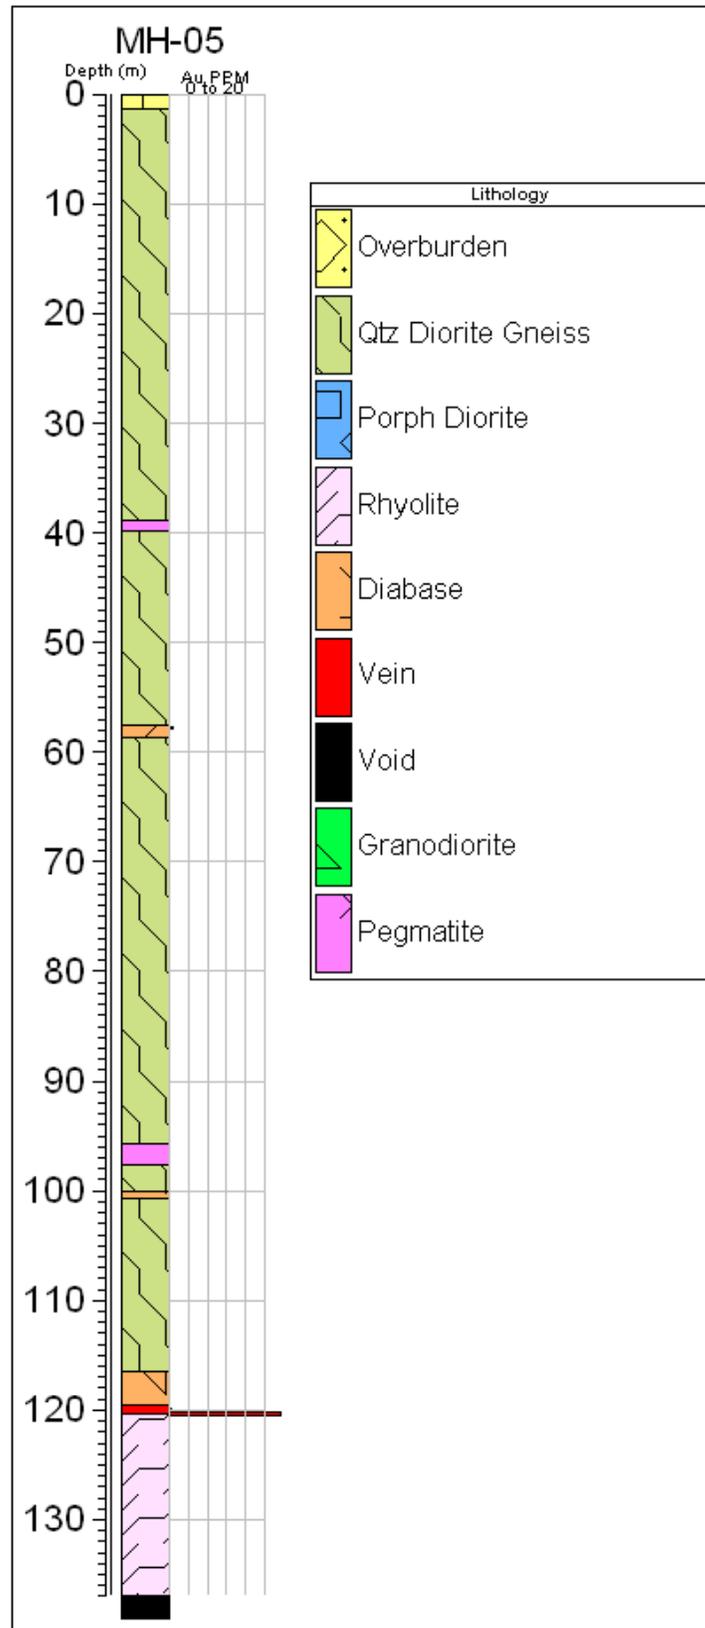
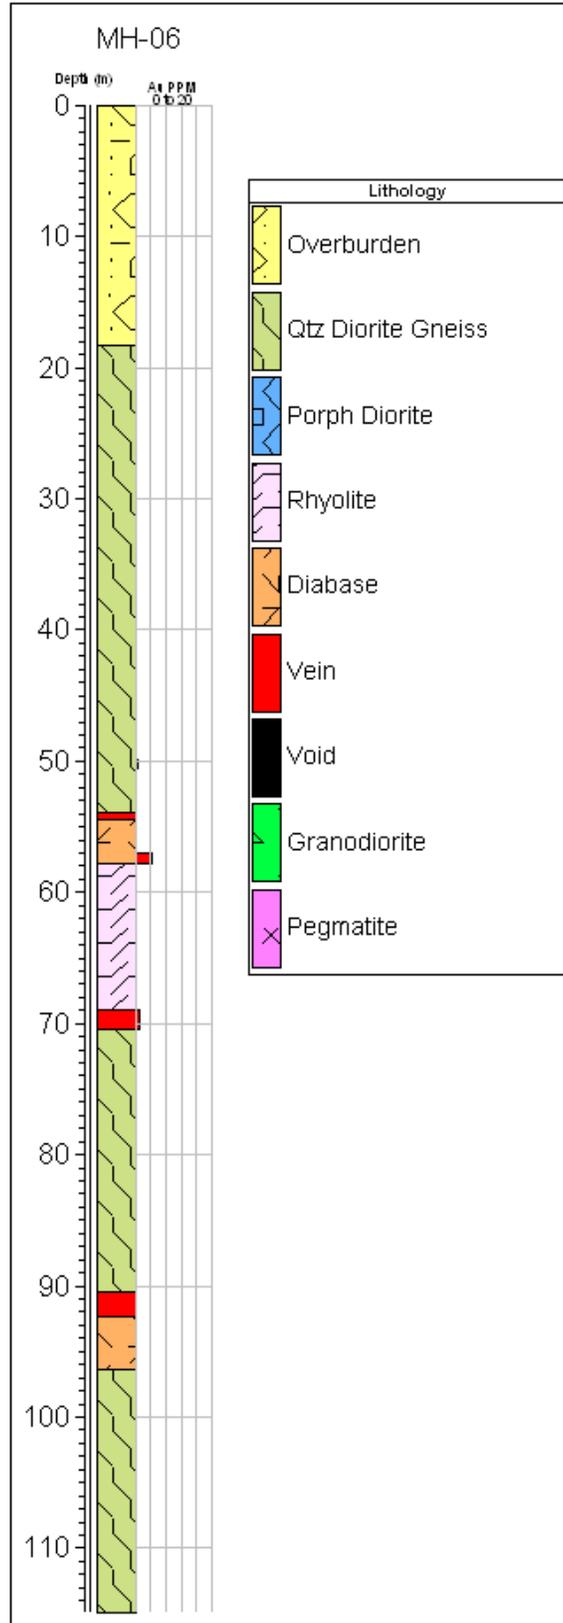
APPENDIX A – DRILL HOLE STRIP LOGS

Strip logs of the Phase I and Phase II holes have been constructed and can be found in Appendix A.
